## Multi-geohazards of Ende city area

IGAN SUPRIATMAN SUTAWIDJAJA<sup>1</sup> and SUGALANG<sup>2</sup>

### ABSTRACT

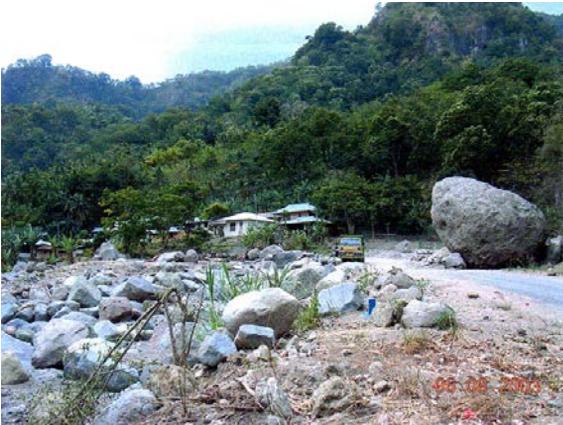
9. The landslide and debris flow disasters in 2003. Heavy rainfall from March 31<sup>st</sup> to April 2<sup>nd</sup>, 2003 caused flash floods, landslides and debris flows in the Ende, Sikka, and Larantuka regions. The areas that suffered most from heavy rains were the following sub-regencies in Ende Regency: Ende, Detusoko, Ndonga, Nangapanda, Maurole, Wolowaru and South Ende. The road from Ende to Bajawa was blocked because the bridge crossing the Lowo Nangaba, 8.2 km west of Ende collapsed in a debris torrent. The road connecting Ende and Maumere towns was blocked by landslides and debris flows in several places. Seventeen houses in the Ndongga Village, 10 km in distance along the road from Ende to Maumere towns were swept away by a debris flow carrying boulders of more than 100 tons in weight and covering the village with 3.5 m of

debris, and 27 people were killed in this event (Figure 2). A big portion of the Ende airport was flooded up to 1 m deep and covered by debris. The airport could not be used for several days. The city of Ende was isolated from the outer world for about one week, since the roads to Bajawa and Maumere cities were blocked and the airport inundated.

Figure 2. The debris flow deposits in the village of Ndungga/Detumbawa. The picture shows the formerly populated area, 27 people lost their lives in this event. The big block to the right was also carried by this debris flow and was estimated to weight more than 100 tons on April 2<sup>nd</sup>, 2003.

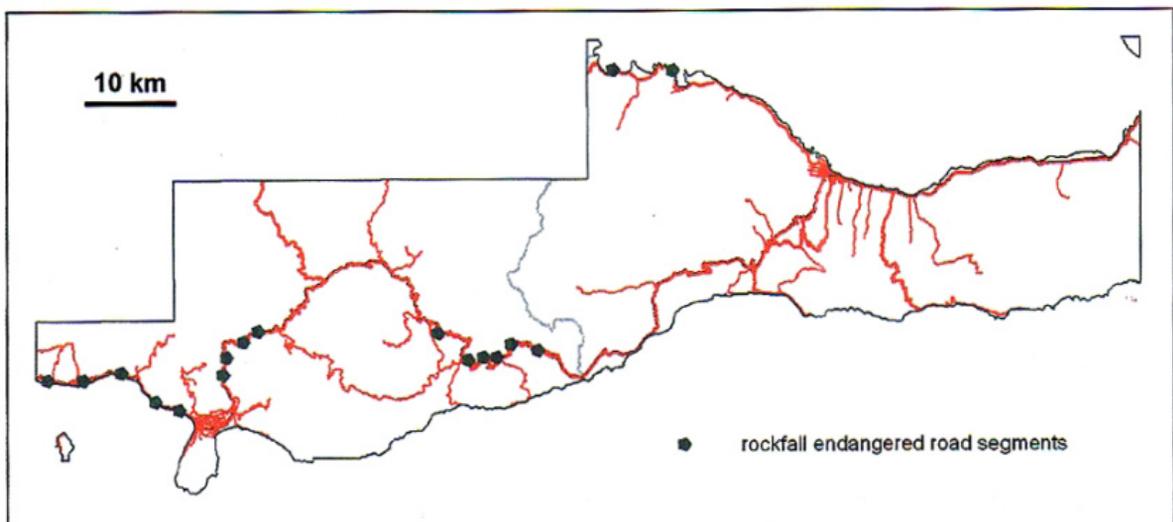
Falling rocks are hazards for areas located below very steep slopes and rock faces. In the project area a problem arose in many parts of the road between Ende city and Detusoko and the road between Ende city and Wolowaru (Figure 3). In those places the road was cut into the natural relief, producing steep and unstable slopes. Although rock falls are not a direct threat to settlements, boulders and gravels frequently block the roads, hampering transportation and economy. Additionally, passing vehicle and people can be subject to falling. Rock falls cannot be precisely predicted, but in the mapped road segments they occurred frequently, so people using the road should be aware of this danger to react accordingly. Therefore, road signs indicating the risk and warning the people should be installed before and at the

Figure 3. The rock-fall endangered segments of major road.

affected road segments. Because rock falls may also block the road, sufficient equipments to clear and repair the road should be available and functional in major settlements.

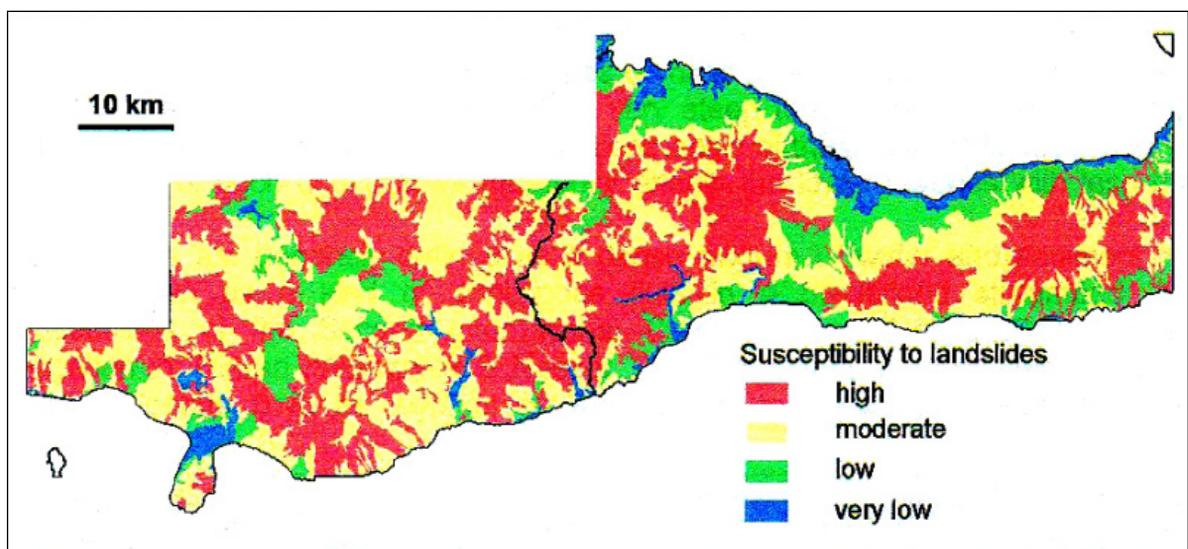
Figure 4. Landslide susceptibility map of the project region, which should be used as a bases for planning and emergency activities.

Generally, there should be no further development within the red zone. In the yellow zone, development should be carried out only after con-

sultation with landslide experts. Settlements, which are located within the red and yellow zones should be protected or replanted by natural vegetation (forest) mainly on the slopes nearby the settlements and vital infrastructure, especially crucial infrastructure for possible cracking. Furthermore, the local people should frequently observe the slopes. In the case cracks occur, the people should plug them with clay to prevent water infiltration and evacuate the possible affected houses.

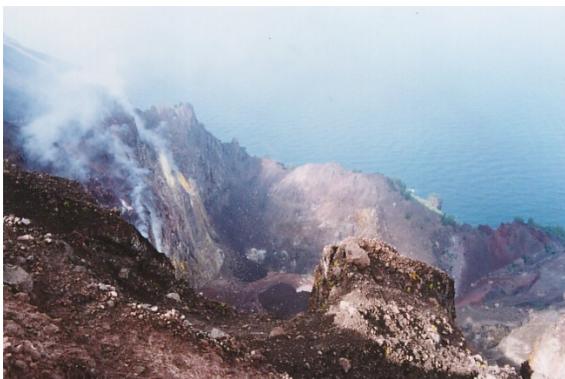
Figure 7. The active crater (K2) of Mt. Iya showing solfataras activities on the north crater wall.

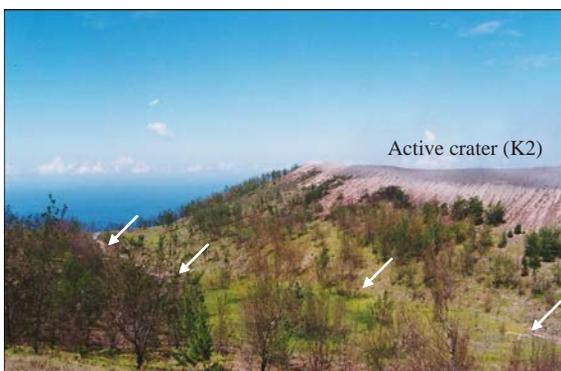
Another major threat from the Iya Volcano which was evaluated during the fieldwork in 2003 and 2006 was a well developed crack that runs across the active crater (K2) of Iya Volcano (Figure 10). Fumaroles appear along the crack where the temperatures ranged between 60° to 80° C. Thermal infrared photograph shows very active fumaroles along the crack (Figure 11). It is thought, that the crack indicates a major weakness within the volcano, which could result in the occurrence of a giant landslide surging into the sea during future eruption of Iya. A computer simulation of this possible landslide is shown in Figure 12, where about 70 million m<sup>3</sup> of rock lies on the unstable area and prone to slide. Although this material will not directly threaten the settlements (since the sliding direction will be south to southwest), the kinetic energy transmitted to the water column may result in the occurrence of tsunami. The amplitude of this tsunami depends very much on the speed and form of the fearful sliding process. It is expected that the whole rock portion surges into the sea at once within minutes (worst case scenario), but it is also possible that the unstable volume would gradually slide down into the sea

Figure 10. A well-developed crack (white arrow) runs all around the active lower crater (K2) of Iya volcano.

within weeks, months, or years. Although no further modelling was carried out to map the tsunami hazard along the coasts in Ende Regency, most of the coasts especially Ende Island should be informed about the alert level of Mount Iya and in case an eruption (before the eruption) occurs. Evacuation of people to higher places should be carried out.

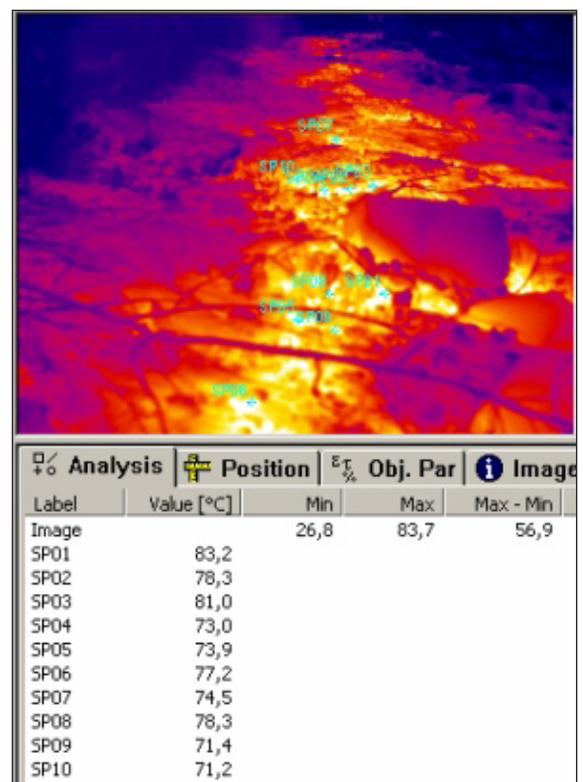
Figure 11. Thermal infrared photograph of the crack showing the temperature of fumaroles along the crack range between 70 to 85 degrees C.

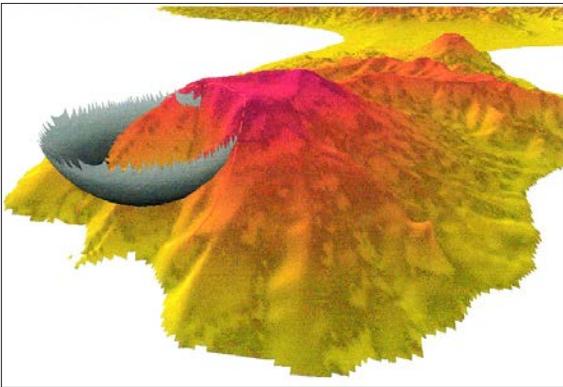
Figure 12. The computer model of Mount Iya simulating a landslide triggered by an eruption. The dash-red line indicating the crack.

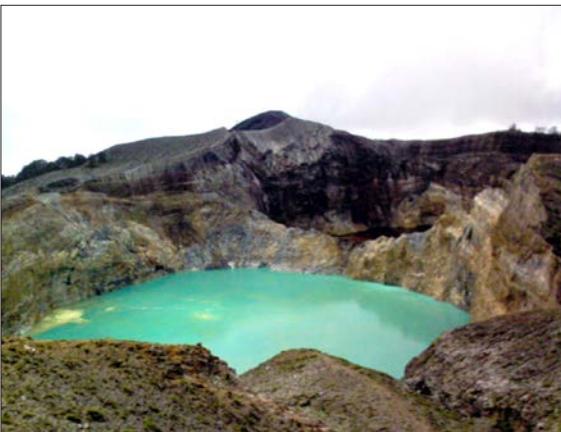
The volcano is one of Indonesia's top tourist attractions and is the main reason why tourists are interested in visiting Flores. The tourists can drive up to a car park, and take a short walk, so the most popular viewpoints are found. These beautiful crater lakes give advantages to the local people who live in the surrounding villages. At present, the Tiwu Ato Polo crater (the red one) is located very close to Tiwu Nua Muri Kooih Fai crater (Figure 16). It is separated only by some meters of a thin wall, which

is quite different from the condition in 1990, when the wall was still thicker, between 15 – 20 m. In case an eruption occurs in one of these two craters, the wall is likely to be damaged and the two lakes would merge to become a big crater. It seems that currently the three craters are very quiet, and even the oldest craters (Tiwu Ato Mbupu) and Tiwu Ato Polo nearby, have almost no activity at all.

Figure 16. Tiwu Nua Muri Kooh Fai crater is one of three different colors of Mount Kelimutu's crater lakes. In the background is Tiwu Ato Polo crater which has a brownish black color.
