## INDONESIAN JOURNAL ON GEOSCIENCE

### Analysis of Lithological Aspects and Their Influence on Slope Stability of the Failed Riverbank in Ajil, Hulu Terengganu, Malaysia

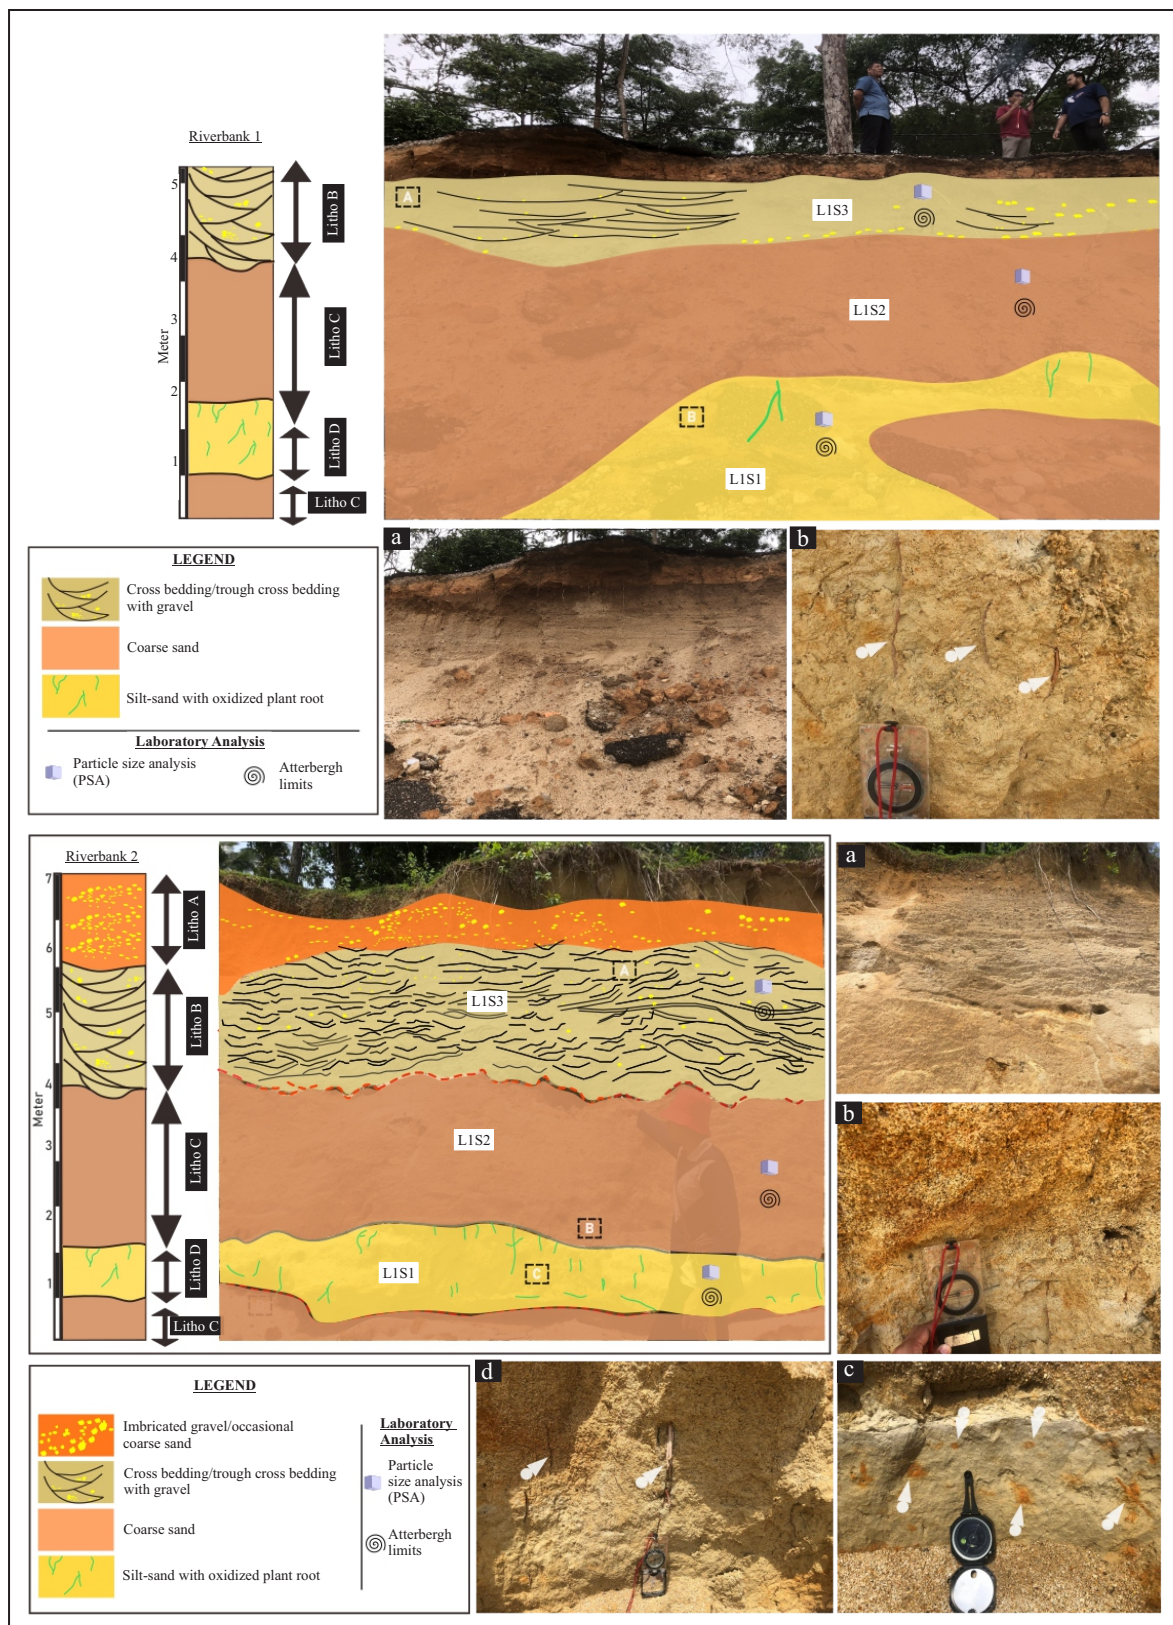
The riverbank exhibits a height of 5.2 m following a significant river overflow (Figure 2a). The logged section reveals various lithological units, which can be categorized into three main types: Litho B, Litho C, and Litho D. Litho B, approximately 1.2 m thick, is distinguished by prominent cross-bedded features. It consists of unconsolidated gravel arranged in an imbricated pattern along the upper portion of the riverbank. Samples obtained along Riverbank 1 were designated with the codes L1S1 to L1S3. Field observations indicate occasional mixing of coarse sand and silt within this area. Litho B is believed to experience high-energy processes that transport larger sediments, and produce cross-bedding features along the riverbank. Cross-bedding occurred due to the sideways and downstream movement of a channel bar, with the inclined layers being steep and slopy (Casnedi and Giulio, 1999; Saikia and Laskar, 2022). The imbrication of gravel suggests the direction of

Figure 2. a) Riverbank 1 exhibits height of 5.2 m following a significant river overflow, categorize by three main types: Litho B, Litho C, and Litho D. b) Riverbank 2, recorded at 7 m above water level and categorized to four distinct lithological units: Litho A, Litho B, Litho C, and Litho D. Note that the sample identification is located on the riverbank as L1S1–L2S3.

water flow. Litho C, situated beneath Litho B and above Litho D, varies in thickness from 1 to 2 m, and displays unsorted coarse grains. This unit is interpreted as part of the river coarse sediment deposition during periods of water overflow, particularly during floods. Litho D represents the lowest section in the logged profile with 1.1 m thick, lying below Litho C. It is characterized by its thinner nature compared to the other lithological divisions, and consists mainly of sand-silt material. Litho D shows a slightly more compact bank compared to Litho B and Litho C. The sand-silt composition suggests a decrease in water flow energy from high to low. During high-energy floods and low-energy dry seasons, the water flow varies, leading to the settlement of silt. Within Litho D, numerous oxidized plant root remnants are also present, indicating past vegetation in the area. Small plants, especially marshes and bushes, can grow along the riverbank when the sand is exposed due to low river water levels. This cycle repeats each year, leaving oxidized plant material on the sand.

This riverbank was recorded at 7 m above water level, based on the logged profile (Figure 2b). The riverbank was clearly exposed when the floodwaters receded, leaving behind the characteristic features of a modern river. The bank is divided into four distinct lithological units: Litho A, Litho B, Litho C, and Litho D. Samples obtained along Riverbank 2 are designated with the codes L2S1 to L2S3. Unlike the profile of riverbank 1, Litho A is absent, possibly eroded away during a major flood event. Litho A in the logged profile is up to 1.32 m thick, consisting of gravel and coarse-grained sand. The gravel at the lower portion of Litho A is aligned in an imbricated pattern, transitioning to a mix of scattered gravel and fine-to-coarse sand grains toward the upper part. This indicates an influx of river sediment during periods of high-water flow. Imbricated gravel can serve as strong evidence of the water flow direction in a modern river channel. Litho B, also found in riverbank

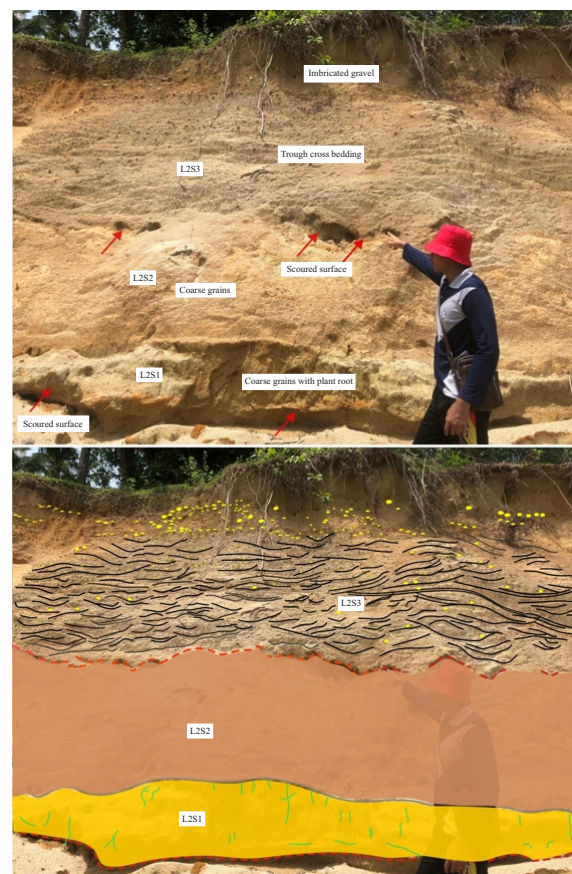
2, is thicker than in riverbank 1. It measures 1.82 m in thickness, and is characterized by cross-bedding structures, such as trough cross-bedding, with granule grains partially covering the area of the riverbank. Cross-bedding forms from the lateral and downstream movement of a channel bar, with steep, sloping layers (Casnedi and Giulio, 1999). Litho B features an erosional base, indicating river scour due to swift water flow during floods. Litho C, situated below Litho B and marked by an erosional base, ranges from 1 to 3 m in thickness. Its characteristics are similar to those of riverbank 1, consisting of unsorted coarse sand. Litho D at riverbank 2 is thinner compared to its exposure at riverbank 1, and is composed of a variety of sand and silt compositions, with a notable abundance of oxidized plant roots (Figure 3).

Figure 3. Lithology and erosional features on riverbank 2. There is trough, imbricated gravel, and scoured surface indication for high energy of water current. Note that the sample identification is located on the riverbank as L1S1–L2S3.

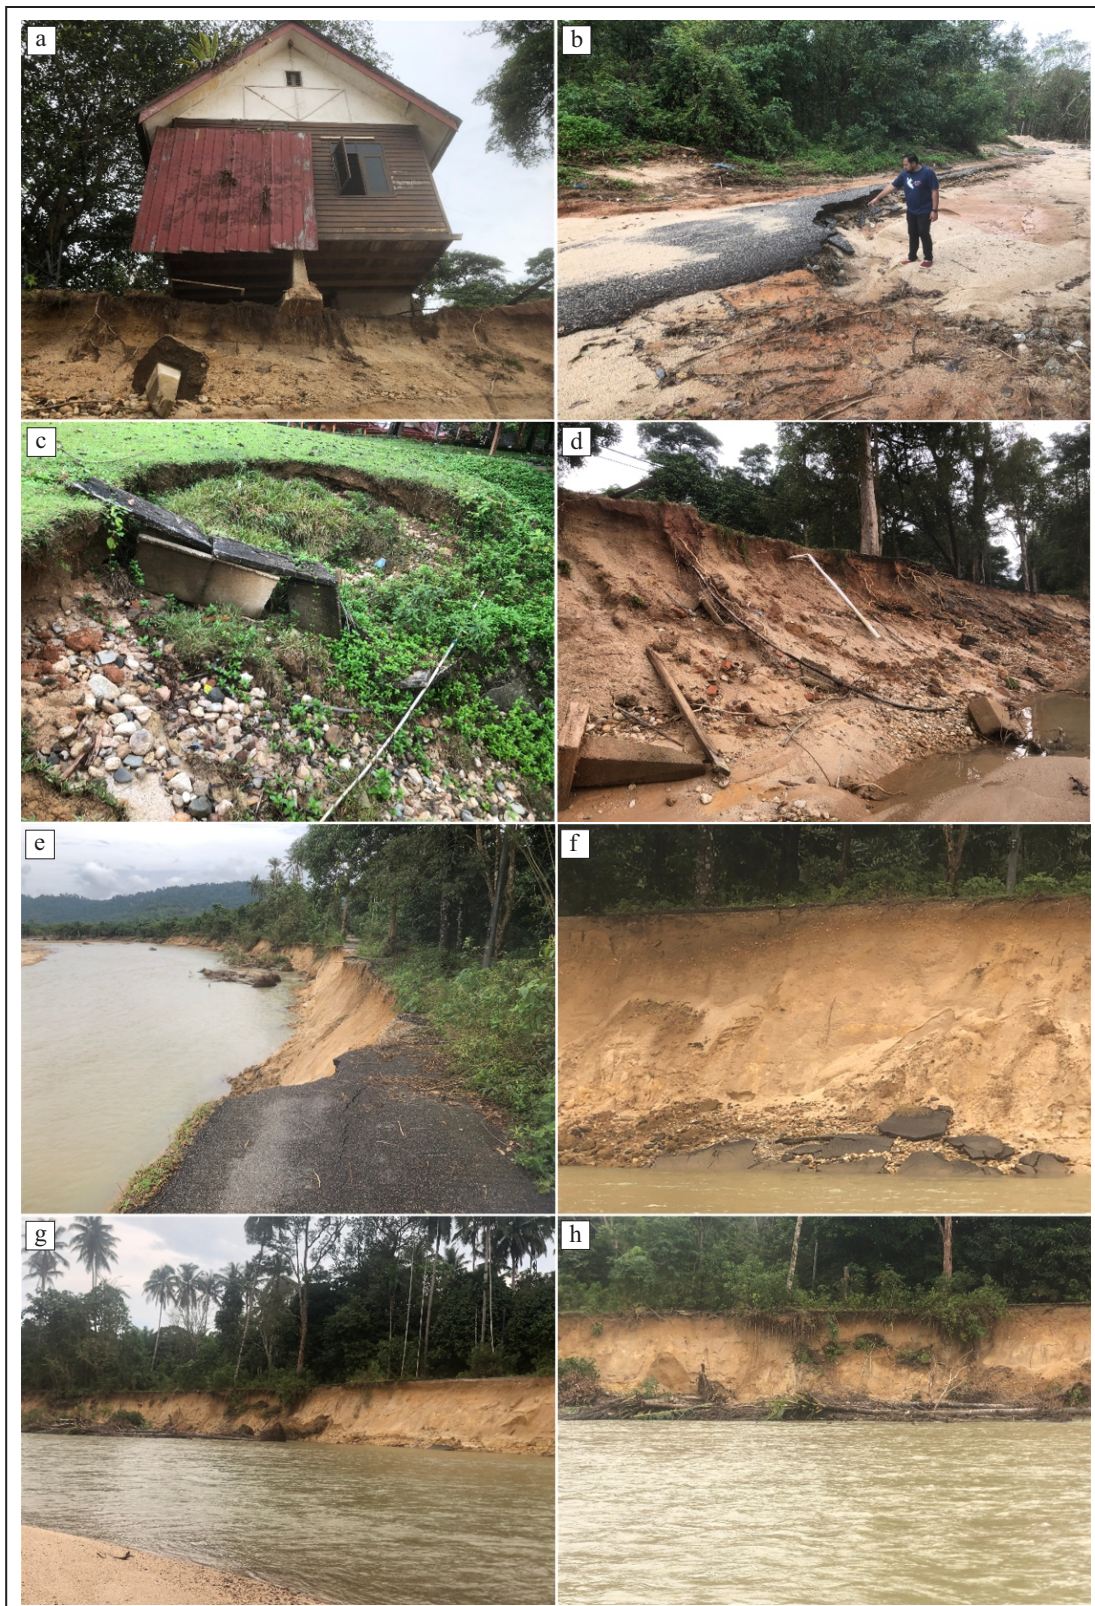
River bank erosion has been observed along the riverbank of the Belukar Bukit recreation centre (Locality 1). Erosion affects an area approximately 100 m horizontally, causing the banks, pedestrian infrastructure, trees, and built structures on the riverbanks to erode (Figures 5a and b). Furthermore, the erosion caused a small landslide scarp after the flood (Figure 5c). The height from the base to the surface of the eroded cliff reaches up to 3 m (Figure 5d). Additionally, the water has dredged up to 2 m towards the riverbank. Such severe erosion is likely to occur when the water flow is fast, and the water level surpasses the original riverbanks. This is evidenced by several uprooted trees, collapsed road and clay sediment in the riverbank toe due to affected by the water flow (Figure 6). According to Lemnitzer *et al.* (2023), the erosion mechanism of the riverbank results in wide scouring at the bottom of the steep bank, leading to landslides during high water levels. Another contributing factor is that the area of Belukar Bukit is closest to the water source, experiencing the highest pressure compared to downstream areas. Increased water velocity exerts stronger pressure on fine-sized soil types compared to river sediments such as pebbly rocks, making them more susceptible to erosion by water. Analysis of the eroded area reveals that the soil at the bottom of the cliff (*i.e.*, L2S1) consists dominantly of silt (Table 1).

The phenomenon of mass movement/riverbank failure on the sandy cliffs/slopes occurs along the riverbanks in the Belukar Bukit Village area (Locality 2). Mass movement that occurs around this river (suspect to occur during the monsoon season of December to March) shows that the banks are unstable, and are easily eroded by water currents. This is because riverbanks always experience fluvial hydraulic erosion and geotechnical instability (*i.e.* gravitational instability) processes that will lead to bank failure (Surian and Rinaldi, 2003; Islam, 2008; Zhao *et al.*, 2022; Zhou *et al.*, 2024). This two process often linked together. Fluvial erosion is the scouring of materials from bank toe by flowing water once the hydraulic force of the river exceeded the resistance threshold of the bank material, thus increasing bank angle and reduce bank stability (Langendoen and Simon 2008; Langendoen *et al.*, 2009). Sediment transport will be initiated when the shear stress overcomes bank material strength that causes the soil particles to be entrained. This happens because shear stress increases as flow increases, while bank material strength normally decreases as bank becomes saturated. This erosion leads to unstable bank, because the forces supporting the weight of the upper bank are reduced (Baracos and Lew, 2003; Lemnitzer *et al.*, 2023). Gravitational failures are frequently preceded by fluvial erosion, which is also responsible in transporting the debris created by gravitational failures. Bank sediments experience varying levels of shear stress due to differences in water pressure along the slope where sediment particles located at the bottom of the slope encounter higher hydraulic head and consequently, more stress than those located higher up the bank where the hydraulic head is lower (Staley *et al.*, 2006; Zhao *et al.*, 2022). This results in a gradient of shear stresses across the bank. The difference in shear stress also leads to the formation of a zone where the bank erodes at a faster rate, particularly at the bottom of the slope, which eventually creates steep or overhanging slopes.

Figure 5. a) A house hanging near the riverbank due to erosion at locality 1. b) Road damage caused by water overflow during the flood at locality 1. c) A small scarp formed by a landslide on the steep riverbank after the flood at locality 1. d) Erosion occurring in the riverbank area at locality 1. e) and f) Tared road fragments at the foot of the bank due to the riverbank collapse. g) An effect of erosion on the steep riverbank, eventually causing a landslide from a different angle. h) Vegetation fell due to a landslide on the riverbank, caused by erosion at Locality 1.

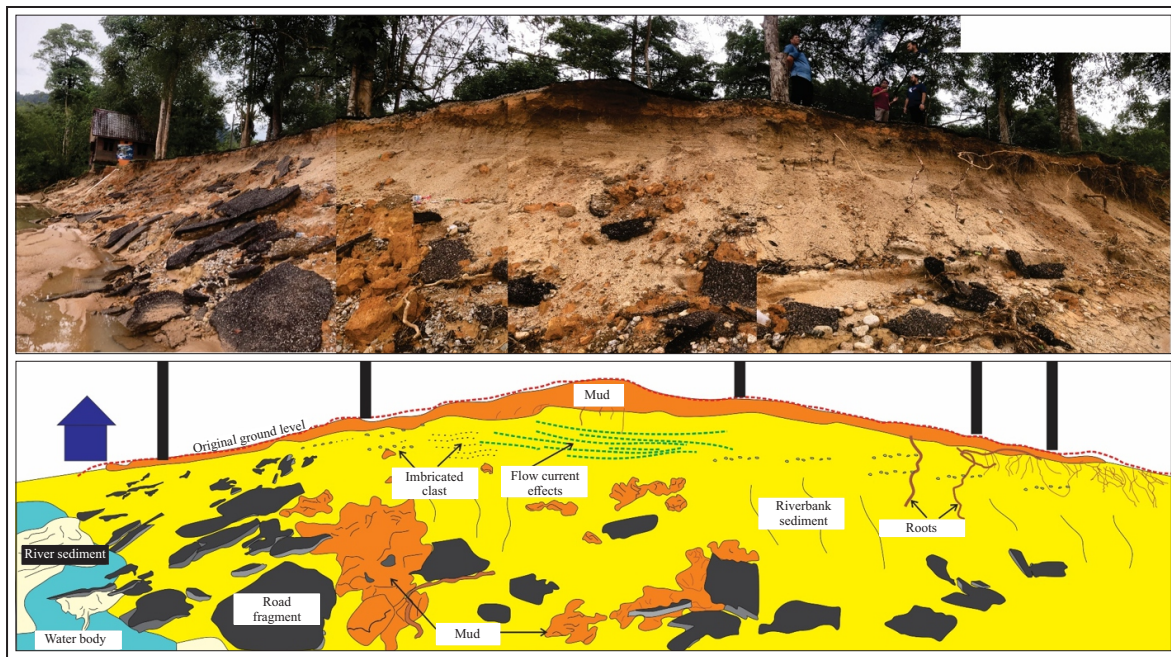
The greatest erosion suggested occurred due to flowing water from the nearest dam (*i.e.* Sultan Mahmud Dam) occupy high energy will be con-

Figure 6. Anatomical sketch of erosion in the Belukar Bukit Waterfall area, Ajil after the rise in water level and also the rapid water current. Clearly observed the effect of waterways through the arrangement of imbrication of pebbles on the riverbanks. Clay sediment as well as broken roads can be seen in the lower part of the river.

sidered as a main factor for erosion. The erosion will take place on the lower part of riverbank by scouring and dredging the bank. The observation has been taken on the riverbank slide. The estimated distance of the landslide from field observations can reach more than 50 m horizontally (Figures 5e and g). The ruins of this riverside slope originally had a tarred road used by local residents. Now, fragments of the road and vegetation can still be seen on the lower riverbank (Figures 5f and h). The original distance between the riverbank and the shoulder of the road is 6 m, and when the collapse occurred, part of the road in the middle collapsed (Figure 7). The collapse of the slope occurs vertically, indicating that the slope is very steep.

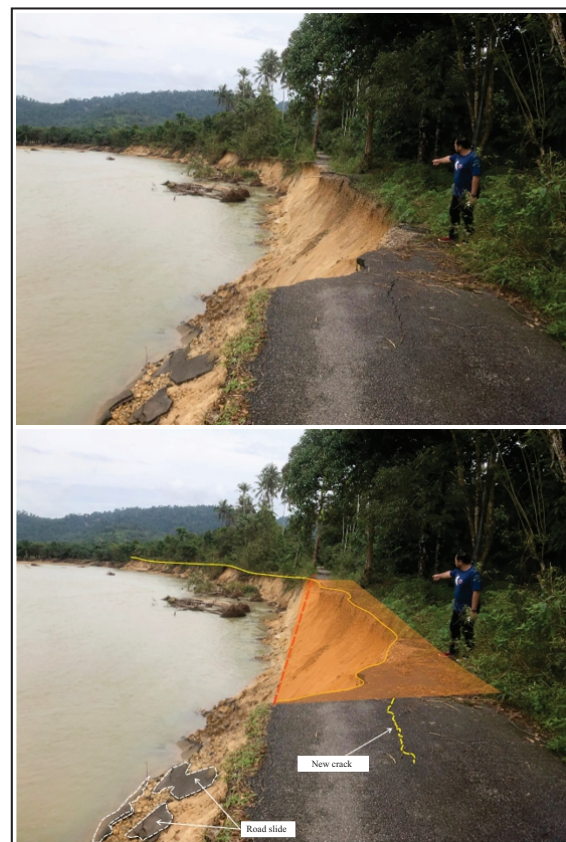
Figure 7. Sketched area of the broken road due to the occurrence of a landslide, also clearly observed the breakdown of the tar road at the bottom of the slope.

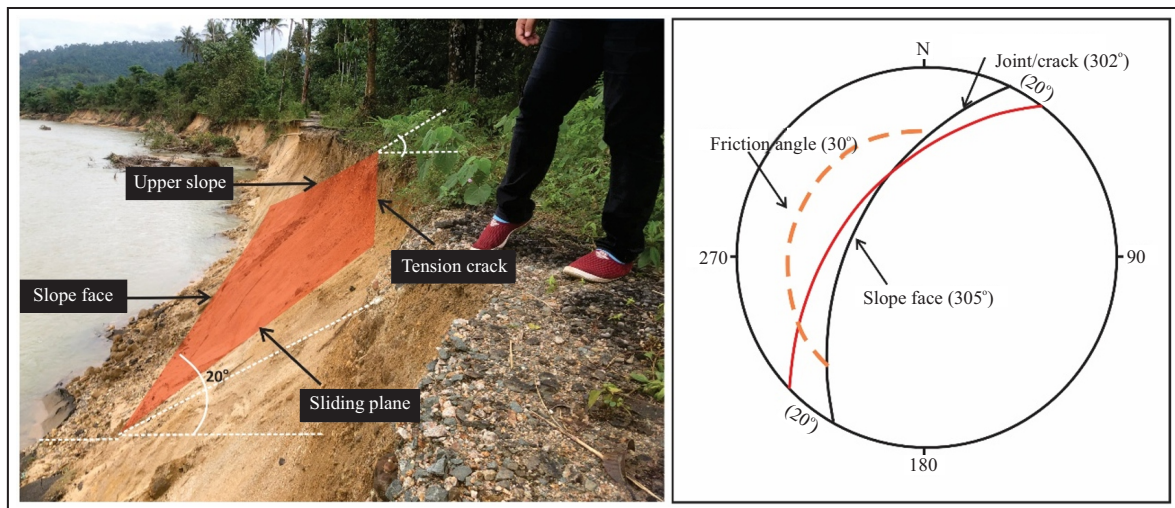
Slope measurements (dips) were recorded in the studied area with relatively high slope values of  $60^\circ$  to  $70^\circ$  and a slope direction of  $305^\circ$ . Using the friction angle,  $\Phi$ , of  $31^\circ$ , a simple kinematic model has been made using a stereonet to determine the type of failure (Figure 8). When a flood recedes, the planar type of riverbanks is usually affected by significant erosion due to several factors. These include; (1) the reduction of the hydrostatic

Figure 8. A field observation analysis of the steep river slope in Sungai Berang at locality 2. A geometric sketch was drawn for the purpose of making it easier to observe mass movement on the river slope. Next to the picture is a geometric sketch showing a kinematic model that is analyzed as a planar failure of the soil due to the sliding plane (friction angle) < the crack (sliding surface angle) < the slope face angle (slope face angle) and the crack plane is parallel to the slope face.

force/pressure caused by the decrease in the water level (Pasha *et al.*, 2025; Eskandarinejad *et al.*, 2025), (2) the time delay between the lowering of the water level in the river and the underground water level which generates a significant uplift force (Wang *et al.*, 2020; Ren *et al.*, 2022), and (3) the decrease in suction force and apparent cohesion caused by the infiltration of rainwater or groundwater seepage (Rinaldi and Casagli, 1999). When a slope is steep, the failure is likely to happen on a smooth and level surface where the block slides into the channel without any rotation.
