### INDONESIAN JOURNAL ON GEOSCIENCE

# Analysis of Lithological Aspects and Their Influence on Slope Stability of the Failed Riverbank in Ajil, Hulu Terengganu, Malaysia

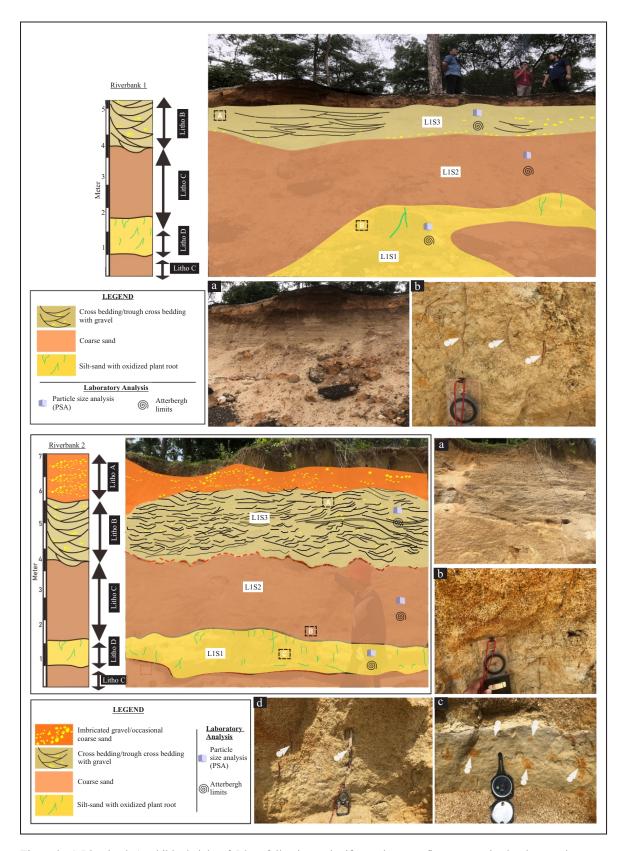
The riverbank exhibits a height of 5.2 m following a significant river overflow (Figure 2a). The logged section reveals various lithological units, which can be categorized into three main types: Litho B, Litho C, and Litho D. Litho B, approximately 1.2 m thick, is distinguished by prominent cross-bedded features. It consists of unconsolidated gravel arranged in an imbricated pattern along the upper portion of the riverbank. Samples obtained along Riverbank 1 were designated with the codes L1S1 to L1S3. Field observations indicate occasional mixing of coarse sand and silt within this area. Litho B is believed to experience high-energy processes that transport larger sediments, and produce cross-bedding features along the riverbank. Cross-bedding occurred due to the sideways and downstream movement of a channel bar, with the inclined layers being steep and slopy (Casnedi and Giulio, 1999; Saikia and Laskar, 2022). The imbrication of gravel suggests the direction of

Figure 2. a) Riverbank 1 exhibits height of 5.2 m following a significant river overflow, categorize by three main types: Litho B, Litho C, and Litho D. b) Riverbank 2, recorded at 7 m above water level and categorized to four distinct lithological units: Litho A, Litho B, Litho C, and Litho D. Note that the sample identification is located on the riverbank as L1S1–L2S3.

water flow. Litho C, situated beneath Litho B and above Litho D, varies in thickness from 1 to 2 m, and displays unsorted coarse grains. This unit is interpreted as part of the river coarse sediment deposition during periods of water overflow, particularly during floods. Litho D represents the lowest section in the logged profile with 1.1 m thick, lying below Litho C. It is characterized by its thinner nature compared to the other lithological divisions, and consists mainly of sand-silt material. Litho D shows a slightly more compact bank compared to Litho B and Litho C. The sand-silt composition suggests a decrease in water flow energy from high to low. During high-energy floods and low-energy dry seasons, the water flow varies, leading to the settlement of silt. Within Litho D, numerous oxidized plant root remnants are also present, indicating past vegetation in the area. Small plants, especially marshes and bushes, can grow along the riverbank when the sand is exposed due to low river water levels. This cycle repeats each year, leaving oxidized plant material on the sand.

This riverbank was recorded at 7 m above water level, based on the logged profile (Figure 2b). The riverbank was clearly exposed when the floodwaters receded, leaving behind the characteristic features of a modern river. The bank is divided into four distinct lithological units: Litho A, Litho B, Litho C, and Litho D. Samples obtained along Riverbank 2 are designated with the codes L2S1 to L2S3. Unlike the profile of riverbank 1, Litho A is absent, possibly eroded away during a major flood event. Litho A in the logged profile is up to 1.32 m thick, consisting of gravel and coarse-grained sand. The gravel at the lower portion of Litho A is aligned in an imbricated pattern, transitioning to a mix of scattered gravel and fine-to-coarse sand grains toward the upper part. This indicates an influx of river sediment during periods of high-water flow. Imbricated gravel can serve as strong evidence of the water flow direction in a modern river channel. Litho B, also found in riverbank 2, is thicker than in riverbank 1. It measures 1.82 m in thickness, and is characterized by cross-bedding structures, such as trough crossbedding, with granule grains partially covering the area of the riverbank. Cross-bedding forms from the lateral and downstream movement of a channel bar, with steep, sloping layers (Casnedi and Giulio, 1999). Litho B features an erosional base, indicating river scour due to swift water flow during floods. Litho C, situated below Litho B and marked by an erosional base, ranges from 1 to 3 m in thickness. Its characteristics are similar to those of riverbank 1, consisting of unsorted coarse sand. Litho D at riverbank 2 is thinner compared to its exposure at riverbank 1, and is composed of a variety of sand and silt compositions, with a notable abundance of oxidized plant roots (Figure 3).

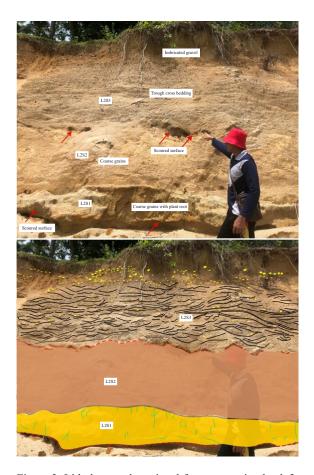
Figure 3. Lithology and erosional features on riverbank 2. There is trough, imbricated gravel, and scoured surface indication for high energy of water current. Note that the sample identification is located on the riverbank as L1S1–L2S3.

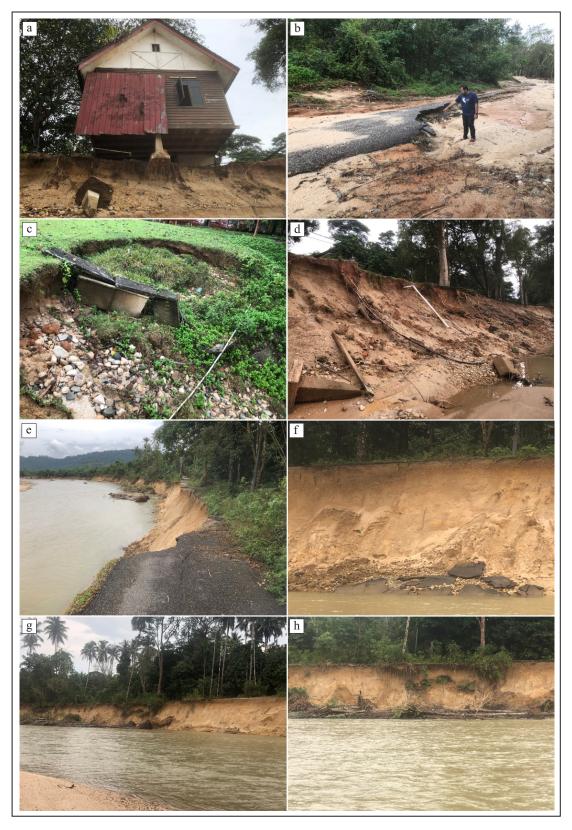
River bank erosion has been observed along the riverbank of the Belukar Bukit recreation centre (Locality 1). Erosion affects an area approximately 100 m horizontally, causing the banks, pedestrian infrastructure, trees, and built structures on the riverbanks to erode (Figures 5a and b). Furthermore, the erosion caused a small landslide scarp after the flood (Figure 5c). The height from the base to the surface of the eroded cliff reaches up to 3 m (Figure 5d). Additionally, the water has dredged up to 2 m towards the riverbank. Such severe erosion is likely to occur when the water flow is fast, and the water level surpasses the original riverbanks. This is evidenced by several uprooted trees, collapsed road and clay sediment in the riverbank toe due to affected by the water flow (Figure 6). According to Lemnitzer et al. (2023), the erosion mechanism of the riverbank results in wide scouring at the bottom of the steep bank, leading to landslides during high water levels. Another contributing factor is that the area of Belukar Bukit is closest to the water source, experiencing the highest pressure compared to downstream areas. Increased water velocity exerts stronger pressure on finesized soil types compared to river sediments such as pebbly rocks, making them more susceptible to erosion by water. Analysis of the eroded area reveals that the soil at the bottom of the cliff (i.e., L2S1) consists dominantly of silt (Table 1).

Figure 5. a) A house hanging near the riverbank due to erosion at locality 1. b) Road damage caused by water overflow during the flood at locality 1. c) A small scarp formed by a landslide on the steep riverbank after the flood at locality 1. d) Erosion occurring in the riverbank area at locality 1. e) and f) Tarred road fragments at the foot of the bank due to the riverbank collapse. g) An effect of erosion on the steep riverbank, eventually causing a landslide from a different angle. h) Vegetation fell due to a landslide on the riverbank, caused by erosion at Locality 1.

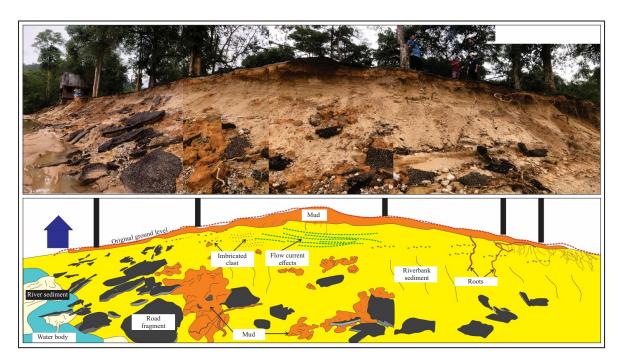
The greatest erosion suggested occurred due to flowing water from the nearest dam (*i.e.* Sultan Mahmud Dam) occupy high energy will be con-

Figure 6. Anatomical sketch of erosion in the Belukar Bukit Waterfall area, Ajil after the rise in water level and also the rapid water current. Clearly observed the effect of waterways through the arrangement of imbrication of pebbles on the riverbanks. Clay sediment as well as broken roads can be seen in the lower part of the river.

sidered as a main factor for erosion. The erosion will take place on the lower part of riverbank by scouring and dreging the bank. The observation has been taken on the riverbank slide. The estimated distance of the landslide from field observations can reach more than 50 m horizontally (Figures 5e and g). The ruins of this riverside slope originally had a tarred road used by local residents. Now, fragments of the road and vegetation can still be seen on the lower riverbank (Figures 5f and h). The original distance between the riverbank and the shoulder of the road is 6 m, and when the collapse occurred, part of the road in the middle collapsed (Figure 7). The collapse of the slope occurs vertically, indicating that the slope is very steep.

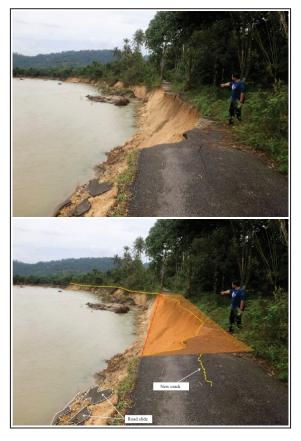
Figure 7. Sketched area of the broken road due to the occurrence of a landslide, also clearly observed the breakdown of the tar road at the bottom of the slope.

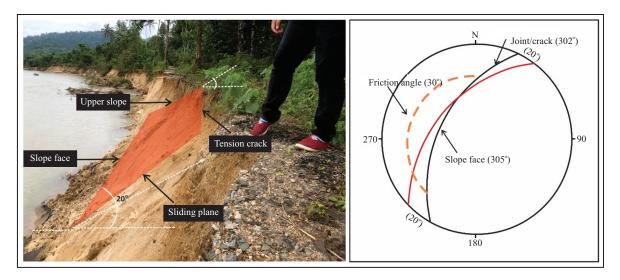
The phenomenon of mass movement/riverbank failure on the sandy cliffs/slopes occurs along the riverbanks in the Belukar Bukit Village area (Locality 2). Mass movement that occurs around this river (suspect to occur during the monsoon season of December to March) shows that the banks are unstable, and are easily eroded by water currents. This is because riverbanks always experience fluvial hydraulic erosion and geotechnical instability (i.e. gravitational instability) processes that will lead to bank failure (Surian and Rinaldi, 2003; Islam, 2008; Zhao et al., 2022; Zhou et al., 2024). This two process often linked together. Fluvial erosion is the scouring of materials from bank toe by flowing water once the hydraulic force of the river exceeded the resistance threshold of the bank material, thus increasing bank angle and reduce bank stability (Langendoen and Simon 2008; Langendoen et al., 2009). Sediment transport will be initiated when the shear stress overcomes bank material strength that causes the soil particles to be entrained. This happens because shear stress increases as flow increases, while bank material strength normally decreases as bank becomes saturated. This erosion leads to unstable bank, because the forces supporting the weight of the upper bank are reduced (Baracos and Lew, 2003; Lemnitzer et al., 2023). Gravitational failures are frequently preceded by fluvial erosion, which is also responsible in transporting the debris created by gravitational failures. Bank sediments experience varying levels of shear stress due to differences in water pressure along the slope where sediment particles located at the bottom of the slope encounter higher hydraulic head and consequently, more stress than those located higher up the bank where the hydraulic head is lower (Staley et al., 2006; Zhao et al., 2022). This results in a gradient of shear stresses across the bank. The difference in shear stress also leads to the formation of a zone where the bank erodes at a faster rate, particularly at the bottom of the slope, which eventually creates steep or overhanging slopes.

Slope measurements (dips) were recorded in the studied area with relatively high slope values of  $60^{\circ}$  to  $70^{\circ}$  and a slope direction of  $305^{\circ}$ . Using the friction angle,  $\Phi$ , of  $31^{\circ}$ , a simple kinematic model has been made using a stereonet to determine the type of failure (Figure 8). When a flood recedes, the planar type of riverbanks is usually affected by significant erosion due to several factors. These include; (1) the reduction of the hydrostatic

Figure 8. A field observation analysis of the steep river slope in Sungai Berang at locality 2. A geometric sketch was drawn for the purpose of making it easier to observe mass movement on the river slope. Next to the picture is a geometric sketch showing a kinematic model that is analyzed as a planar failure of the soil due to the sliding plane (friction angle) < the crack (sliding surface angle) < the slope face angle (slope face angle) and the crack plane is parallel to the slope face.

force/pressure caused by the decrease in the water level (Pasha *et al.*, 2025; Eskandarinejad *et al.*, 2025), (2) the time delay between the lowering of the water level in the river and the underground water level which generates a significant uplift force (Wang *et al.*, 2020; Ren *et al.*, 2022), and (3) the decrease in suction force and apparent cohesion caused by the infiltration of rainwater or groundwater seepage (Rinaldi and Casagli, 1999). When a slope is steep, the failure is likely to happen on a smooth and level surface where the block slides into the channel without any rotation.
