## Multi-geohazards of Ende city area

IGAN SUPRIATMAN SUTAWIDJAJA<sup>1</sup> and SUGALANG<sup>2</sup>

<sup>1</sup>Center for Volcanology and Geological Hazard Mitigation,  
Jl. Diponegoro No. 57, Bandung

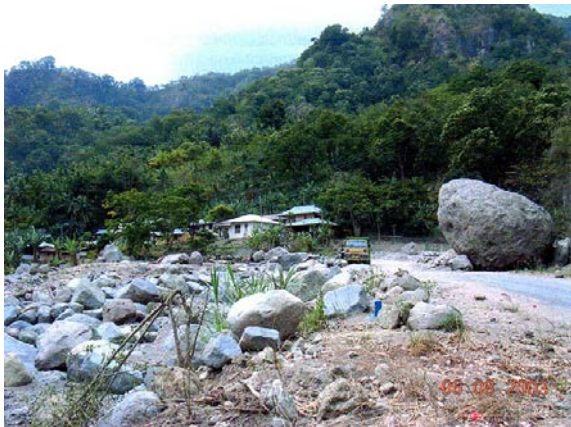
debris, and 27 people were killed in this event (Figure 2). A big portion of the Ende airport was flooded up to 1 m deep and covered by debris. The airport could not be used for several days. The city of Ende was isolated from the outer world for about one week, since the roads to Bajawa and Maumere cities were blocked and the airport inundated.

Figure 2. The debris flow deposits in the village of Ndungga/Detumbawa. The picture shows the formerly populated area, 27 people lost their lives in this event. The big block to the right was also carried by this debris flow and was estimated to weight more than 100 tons on April 2<sup>nd</sup>, 2003.

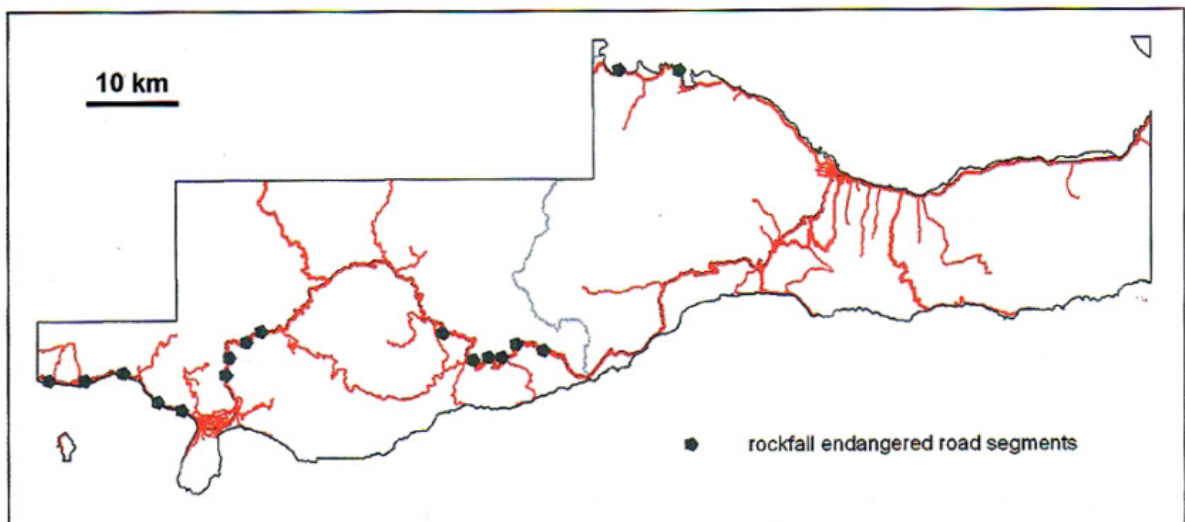
Falling rocks are hazards for areas located below very steep slopes and rock faces. In the project area a problem arose in many parts of the road between Ende city and Detusoko and the road between Ende city and Wolowaru (Figure 3). In those places the road was cut into the natural relief, producing steep and unstable slopes. Although rock falls are not a direct threat to settlements, boulders and gravels frequently block the roads, hampering transportation and economy. Additionally, passing vehicle and people can be subject to falling. Rock falls cannot be precisely predicted, but in the mapped road segments they occurred frequently, so people using the road should be aware of this danger to react accordingly. Therefore, road signs indicating the risk and warning the people should be installed before and at the

Figure 3. The rock-fall endangered segments of major road.

affected road segments. Because rock falls may also block the road, sufficient equipments to clear and repair the road should be available and functional in major settlements.

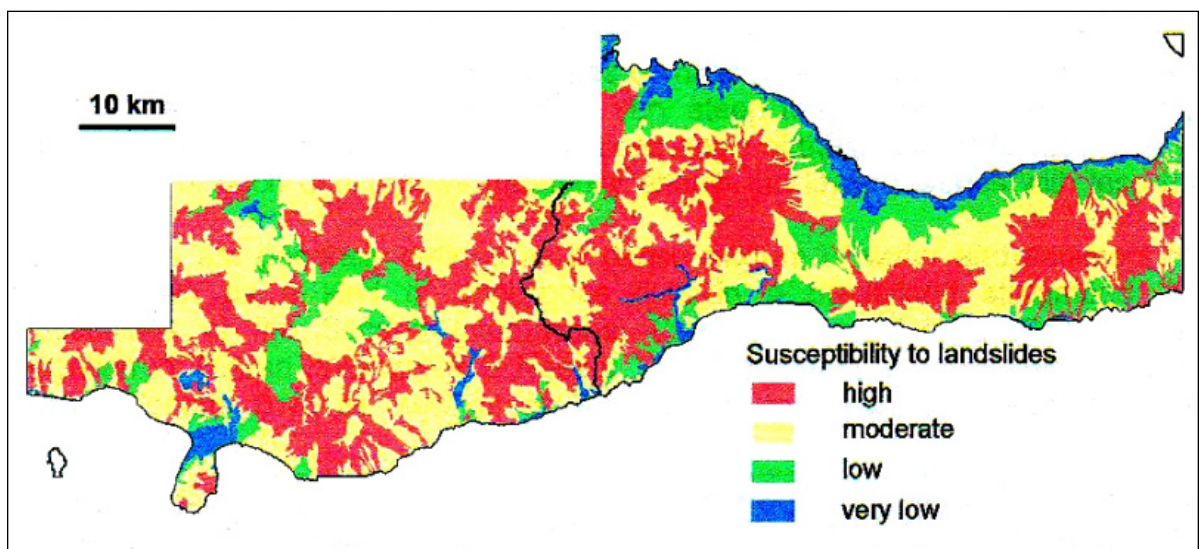
Figure 4. Landslide susceptibility map of the project region, which should be used as a bases for planning and emergency activities.

Generally, there should be no further development within the red zone. In the yellow zone, development should be carried out only after con-

sultation with landslide experts. Settlements, which are located within the red and yellow zones should be protected or replanted by natural vegetation (forest) mainly on the slopes nearby the settlements and vital infrastructure, especially crucial infrastructure for possible cracking. Furthermore, the local people should frequently observe the slopes. In the case cracks occur, the people should plug them with clay to prevent water infiltration and evacuate the possible affected houses.

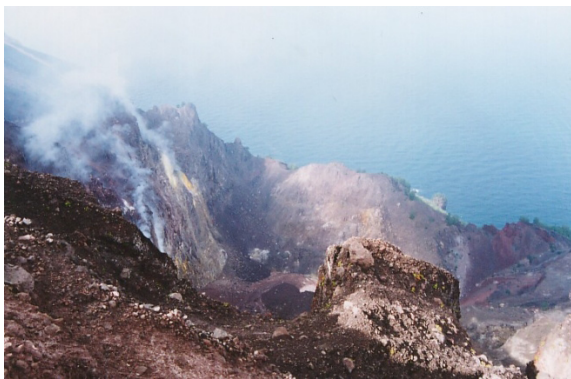
Figure 7. The active crater (K2) of Mt. Iya showing solfatara activities on the north crater wall.

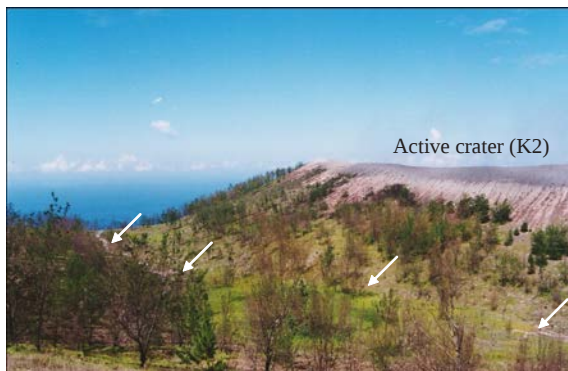
Another major threat from the Iya Volcano which was evaluated during the fieldwork in 2003 and 2006 was a well developed crack that runs across the active crater (K2) of Iya Volcano (Figure 10). Fumaroles appear along the crack where the temperatures ranged between 60° to 80° C. Thermal infrared photograph shows very active fumaroles along the crack (Figure 11). It is thought, that the crack indicates a major weakness within the volcano, which could resulted in the occurrence of a giant landslide surging into the sea during future eruption of Iya. A computer simulation of this possible landslide is shown in Figure 12, where about 70 million m<sup>3</sup> of rock lies on the unstable area and prone to slide. Although this material will not directly threat the settlements (since the sliding direction will be south to southwest), the kinetic energy transmitted to the water column may result in the occurrence of tsunami. The amplitude of this tsunami depends very much on the speed and form of the fearfull sliding process. It is expected that the whole rock portion surges into the sea at once within minutes (worst case scenario), but it is also possible that the unstable volume would gradually slide down into the sea

Figure 10. A well-developed crack (white arrow) runs all around the active lower crater (K2) of Iya volcano.

within weeks, months, or years. Although no further modelling was carried out to map the tsunami hazard along the coasts in Ende Regency, most of the coasts especially Ende Island should be informed about the alert level of Mount Iya and in case an eruption (before the eruption) occurs. Evacuation of people to higher places should be carried out.

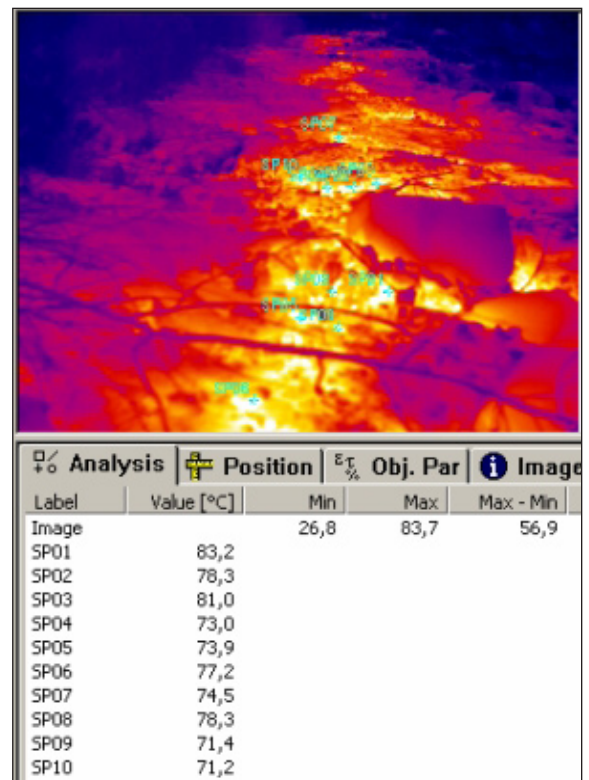
Figure 11. Thermal infrared photograph of the crack showing the temperature of fumaroles along the crack range between 70 to 85 degrees C.

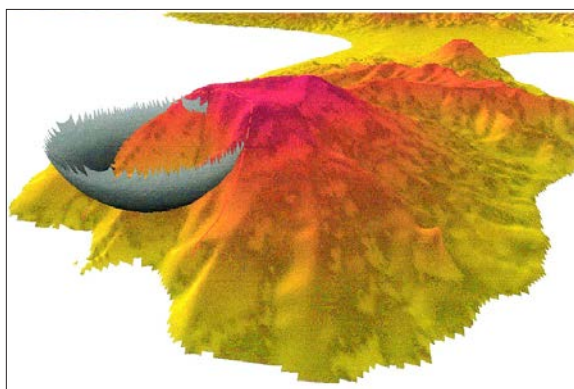
Figure 12. The computer model of Mount Iya simulating a landslide triggered by an eruption. The dash-red line indicating the crack.

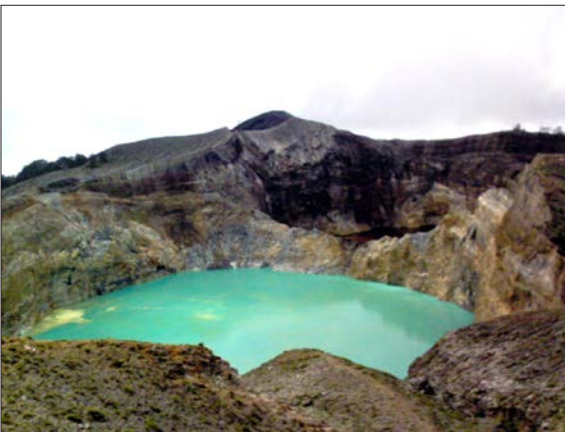
The volcano is one of Indonesia's top tourist attractions and is the main reason why tourists are interested in visiting Flores. The tourists can drive up to a car park, and take a short walk, so the most popular viewpoints are found. These beautiful crater lakes give advantages to the local people who live in the surrounding villages. At present, the Tiwu Ato Polo crater (the red one) is located very close to Tiwu Nua Muri Kooh Fai crater (Figure 16). It is separated only by some meters of a thin wall, which

is quite different from the condition in 1990, when the wall was still thicker, between 15 – 20 m. In case an eruption occurs in one of these two craters, the wall is likely to be damaged and the two lakes would merge to become a big crater. It seems that currently the three craters are very quiet, and even the oldest craters (Tiwu Ato Mbupu) and Tiwu Ato Polo nearby, have almost no activity at all.

Figure 16. Tiwu Nua Muri Kooh Fai crater is one of three different colors of Mount Kelimutu's crater lakes. In the background is Tiwu Ato Polo crater which has a brownish black color.
