The Sliding Surface Determination of A Deep-seated Landslide on Cisumdawu Highway, West Java, Based on The Electrical Resistivity Tomography

IMAM SANTOSA^{1,2}, NANA SULAKSANA², EUIS TINTIN YUNINGSIH², and ZUFIALDI ZAKARIA²

²Faculty of Geological Engineering, University of Padjadjaran

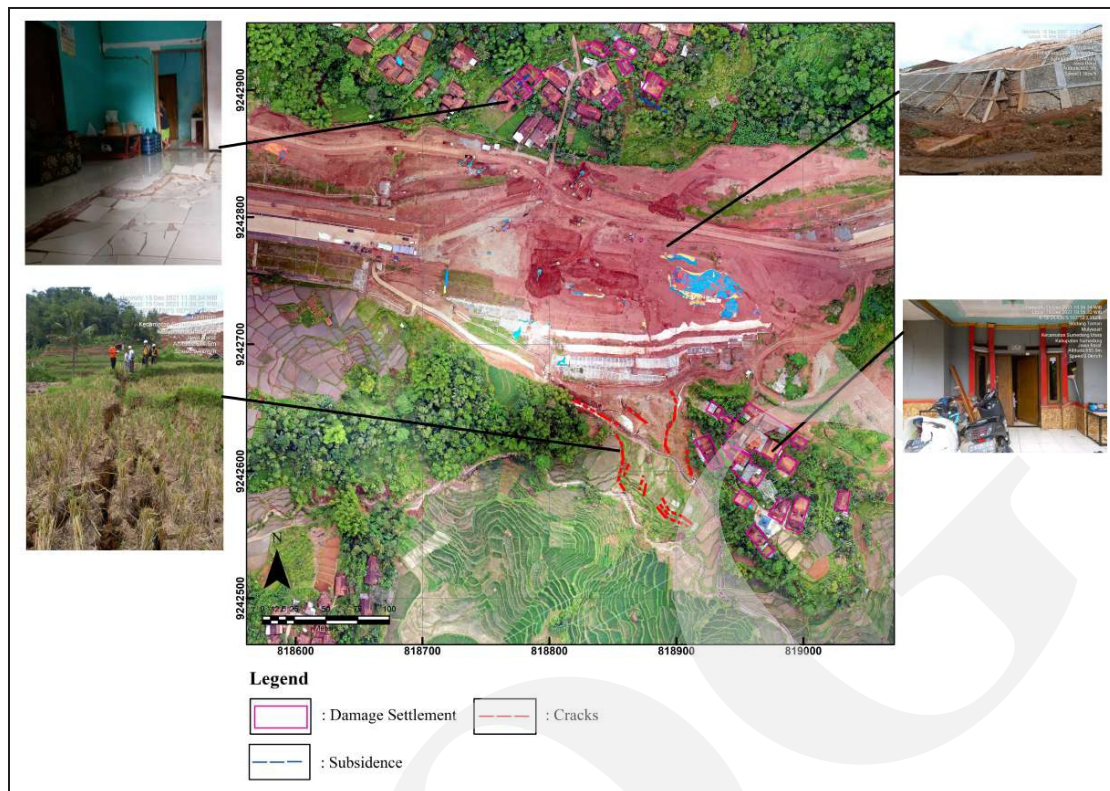
2022. The impacts of the event are widespread, such as cracks in buildings and infrastructure (highway). Therefore, the recovery will be a lengthy process and costly (Figure 2).

Figure 2. Landslide effects on infrastructure and buildings on Cisumdawu Highway Station 21.

The direction of the slow-moving landslide is N 170-180° E, and is characterized by cracks and land subsidence in residential areas, plantation lands, rice fields, and highways. The slow-moving landslide and land subsidence occurred on an under-construction highway, settlements, and paddy fields. These caused eighteen residents' houses, including the foundation and floor, be moderately damaged. Generally, the land in this area is used as settlement and rice field. (Figure 2).

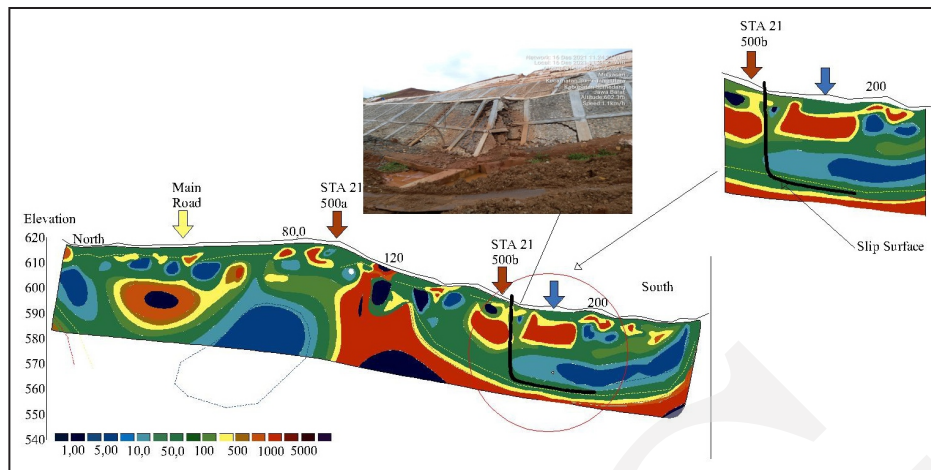
Figure 5. Section of 2D resistivity for Line 2A.

For Line 2A (Figure 5), several soil gradations were detected in a scattered distribution. In Line 3A (Figure 6), the result showed that several water-saturated zones were detected from the north to the south. The boundary between the zone with a low resistivity value and a harder rock in the south part is interpreted as a slip surface. The localized weak zone extending from the left to the right side was 24–26m deep from the north to the south.

percolated with water accumulation was mainly located at the centre and slightly downslope to the southern area. Due to the presence of a percolated water zone, the zone of low resistivity value was produced. This zone might have developed due to water seepage from surface runoff, direct precipitation through porous subsurface materials, and the pre-existing groundwater zone in the area.

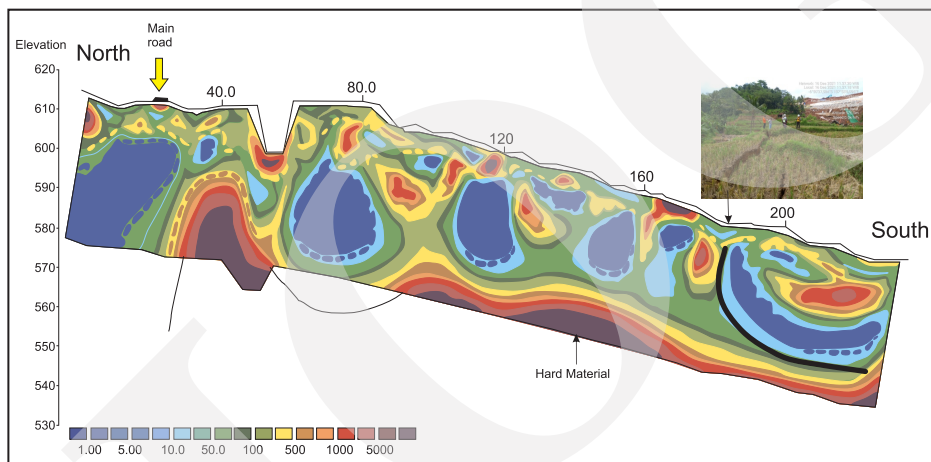
Figure 6. Section of 2D resistivity for Line 3A.

Since a weak zone was found in Figures 5, 6 and 7, it was assumed that Line 2A, 3A, and Line 4A were particularly vulnerable to soil erosion or slope failure. This weak zones were close to the downslope of the pictures, underneath, on the right-hand side. The phenomenon might be influenced by surface water seepage that reaches the natural drain/valley or water path through the permeable material. Figures 5, 6, and 7 show significant differences in resistivity values on Line 2A, 3A, and Line 4A, respectively, with the depth of 24–26m from the ground surface. The high resistivity value originated from hard materials, including gravel, boulders, and bedrock. The localized weak zone extending from the left to the right side was 24-26m deep, from the north to the south. Due to its low resistivity levels, the section

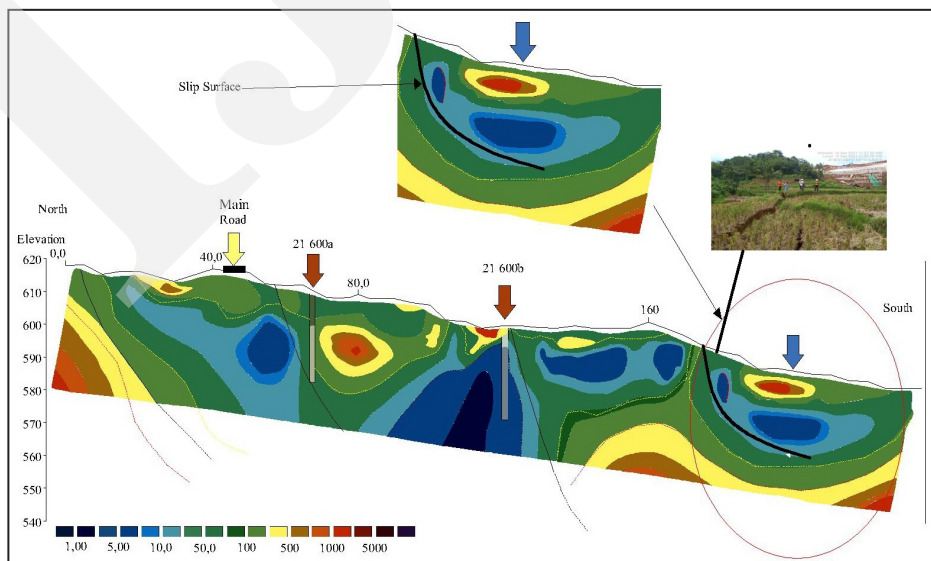
Figure 7. Section of 2D resistivity for Line 4A.

However, the majority of Line 4A (Figure 7) was in the centre, on the right with a shallower depth, and on the left with some deeper depths inside the resistivity images. The bore core data of Station 21+600 and Station 21+550A were used to interpret the subsurface layer. Based on Station 21+600, the subsurface profile material began as a medium stiff layer of clay to sandy clay at a depth of 9 m, which gradually changed to a harder layer at a deeper level.

In line 4A (Figure 7), the result showed that the resistivity tomography for permeable soil percolated with water was mainly located at the left-hand side with a shallow depth, the right-hand side, and within the resistivity image produced. For Line 2A (Figure 5), it was discovered that the resistivity tomography of permeable soil

Based on both resistivity images produced in Figure 7, the hard zone was randomly distributed. The resistivity images in Figures 5, 6, and 7 also demonstrated that the thickness of the existing hard materials varied approximately from 10 m to 30 m.

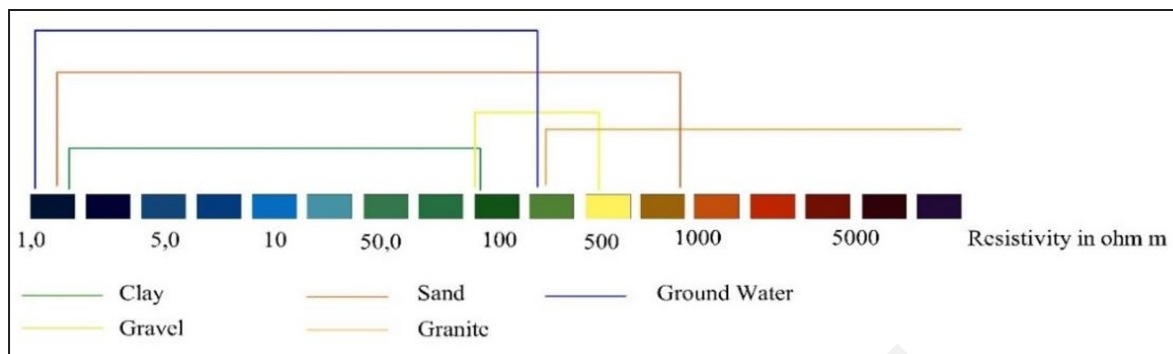
Figure 8. Summary of resistivity interpretation on Cisumdawu Highway.

The layer with a low resistivity value is water-saturated and silt or clay at 1–100 Ω m. A fairly higher resistivity value was discovered below the water-saturated layer and a harder rock in some places, with a resistivity of 50–200 Ω m, which is assumed to be clay. The boundary between the two layers or fields with different resistivity values was considered a slip surface.

21+600 and Station 21+550A of Cisumdawu Highway reveals that the percolating water zone in the permeable loose soil is located above the clay that is impermeable zone having N-SPT values between 40–60 at a depth of 24–26m, and is a landslide sliding surface (Figure 8). Therefore, this region needs to be strengthened or protected in the future using proper geotechnical ground stabilization procedures.

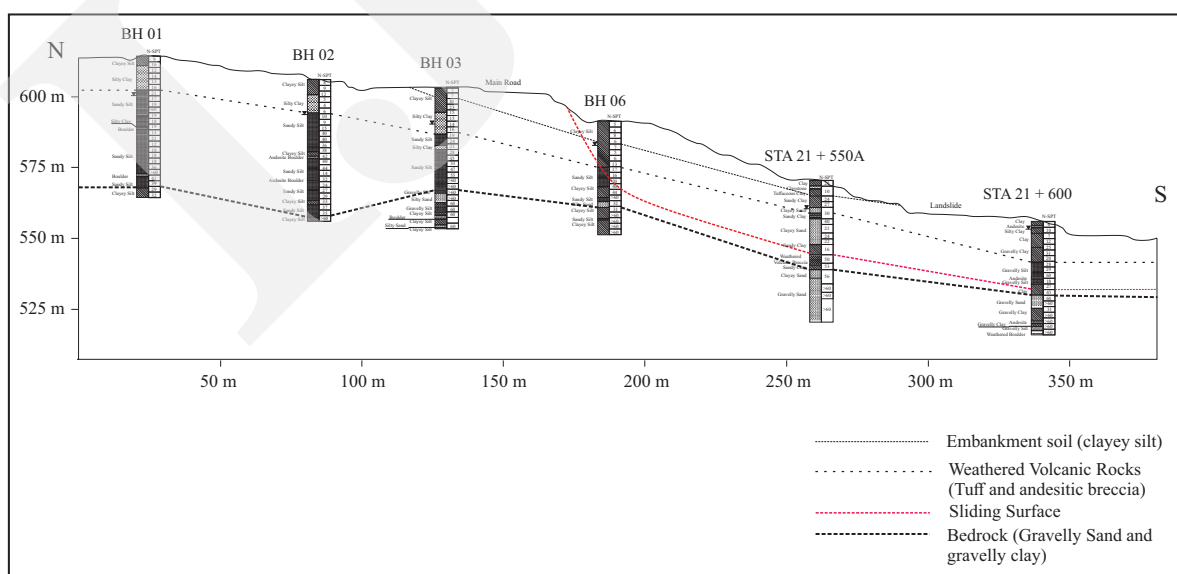
Based on the geotechnical cross-section through boreholes BH1, BH2, BH3, BH6, Sta 21+550A, and Sta 21+600 along Line 3A (Figure 9), the lithology of the researched area can be divided into four sections. They are the embankment soil (clayey soil) at a depth of 0-10 m with an N-SPT value of 5-10. The weathered volcanic rocks (tuff and andesitic breccia) at a depth of 10-15 m have an N-SPT value of 6-27. The weathered volcanic rocks (tuff and andesitic breccia) at a depth of 15-37 m have an N-SPT value of 10-32. The bedrock (gravelly sand and gravelly clay) at a depth of >37m has an N_SPT 32-60. Lithology of the sliding surface (red dashed line) is sandy silt, sandy clay, and clay with an N-SPT of more than 40.

Lithology of the sliding surface is sandy silt, sandy clay, and clay at a depth of 24 –26 m. The slope of the sliding surface is 20° with an N-SPT of more than 27. The results of this study can be used practically for determining a slip surface at the site .

Figure 9. Geotechnical cross-section for some boreholes at Cisumdawu Highway Station 21. The cross-section shows the lithology correlation between each borehole. The dashed red line shows the estimated sliding surface of each borehole.

Based on the data presented, the installation of bore piles and groundwater level monitoring need to be done as mitigation efforts. The framework implemented in this study is beneficial, and other landslide investigations can benefit from the combination of similar methods. For further research, the determination of rocks or soil weathering is recommended. Planning landslide mitigation using the advice from previous studies is also beneficial.
