The Sliding Surface Determination of A Deep-seated Landslide on Cisumdawu Highway, West Java, Based on The Electrical Resistivity Tomography

IMAM SANTOSA^{1,2}, NANA SULAKSANA², EUIS TINTIN YUNINGSIH², and ZUFIALDI ZAKARIA²

Santosa, I., Sulaksana, N., Yuningsih, E.T., and Zakaria, Z., 2024. The Sliding Surface Determination of A Deep-seated Landslide on Cisumdawu Highway, West Java, Based on The Electrical Resistivity Tomography. *Indonesian Journal on Geoscience*, 11 (2), p.189-199. DOI: [10.17014/ijog.11.2.189-199](https://doi.org/10.17014/ijog.11.2.189-199)

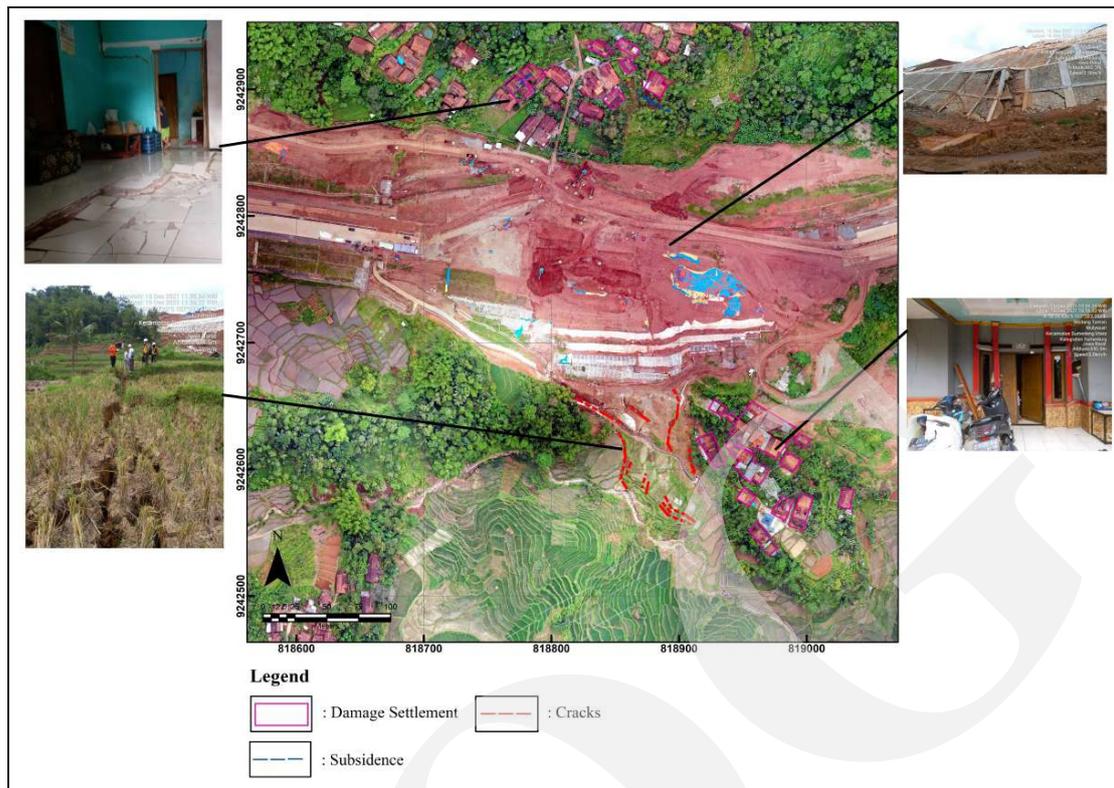
2022. The impacts of the event are widespread, such as cracks in buildings and infrastructure (highway). Therefore, the recovery will be a lengthy process and costly (Figure 2).

Figure 2. Landslide effects on infrastructure and buildings on Cisumdawu Highway Station 21.

The direction of the slow-moving landslide is N 170-180° E, and is characterized by cracks and land subsidence in residential areas, plantation lands, rice fields, and highways. The slow-moving landslide and land subsidence occurred on an under-construction highway, settlements, and paddy fields. These caused eighteen residents' houses, including the foundation and floor, be moderately damaged. Generally, the land in this area is used as settlement and rice field. (Figure 2).

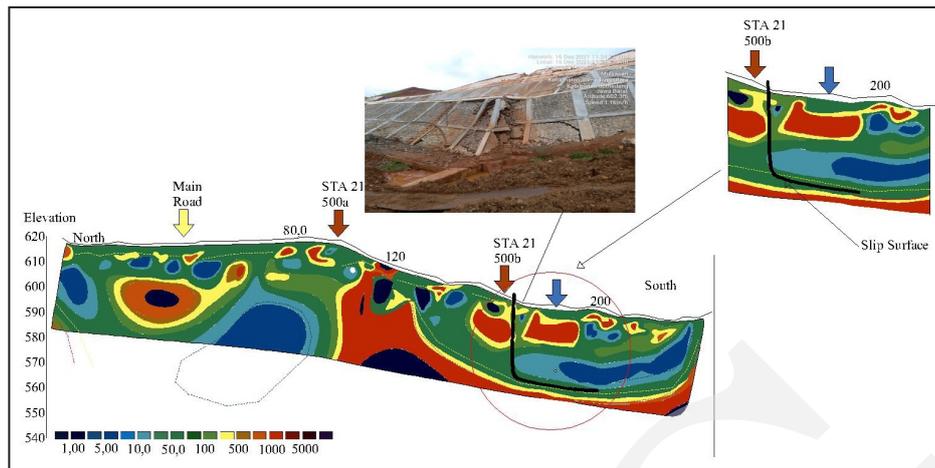
Figure 5. Section of 2D resistivity for Line 2A.

For Line 2A (Figure 5), several soil gradations were detected in a scattered distribution. In Line 3A (Figure 6), the result showed that several water-saturated zones were detected from the north to the south. The boundary between the zone with a low resistivity value and a harder rock in the south part is interpreted as a slip surface. The localized weak zone extending from the left to the right side was 24–26m deep from the north to the south.

In line 4A (Figure 7), the result showed that the resistivity tomography for permeable soil percolated with water was mainly located at the left-hand side with a shallow depth, the right-hand side, and within the resistivity image produced. For Line 2A (Figure 5), it was discovered that the resistivity tomography of permeable soil

percolated with water accumulation was mainly located at the centre and slightly downslope to the southern area. Due to the presence of a percolated water zone, the zone of low resistivity value was produced. This zone might have developed due to water seepage from surface runoff, direct precipitation through porous subsurface materials, and the pre-existing groundwater zone in the area.

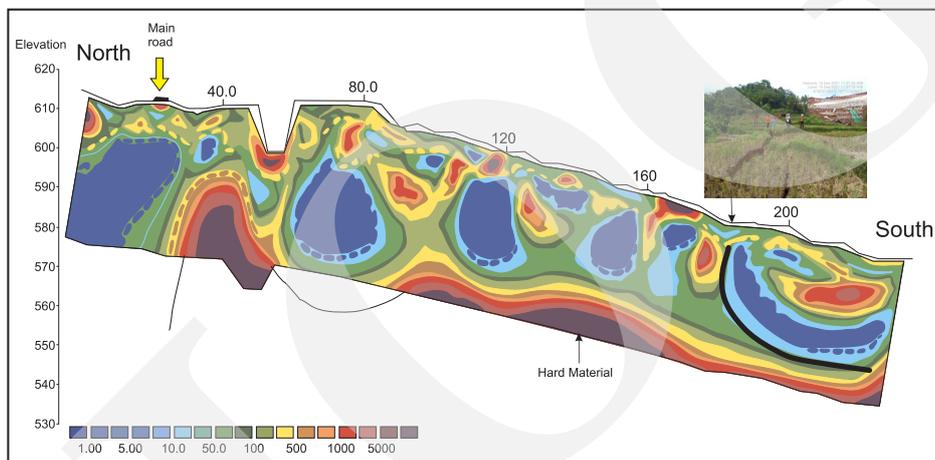
Figure 6. Section of 2D resistivity for Line 3A.

Since a weak zone was found in Figures 5, 6 and 7, it was assumed that Line 2A, 3A, and Line 4A were particularly vulnerable to soil erosion or slope failure. This weak zones were close to the downslope of the pictures, underneath, on the right-hand side. The phenomenon might be influenced by surface water seepage that reaches the natural drain/valley or water path through the permeable material. Figures 5, 6, and 7 show significant differences in resistivity values on Line 2A, 3A, and Line 4A, respectively, with the depth of 24–26m from the ground surface. The high resistivity value originated from hard materials, including gravel, boulders, and bedrock. The localized weak zone extending from the left to the right side was 24-26m deep, from the north to the south. Due to its low resistivity levels, the section

of the segment can develop into a hazardous zone. A weakness plane (slip surface) for any slope failures can be viewed as the boundary between high and low resistivity values.

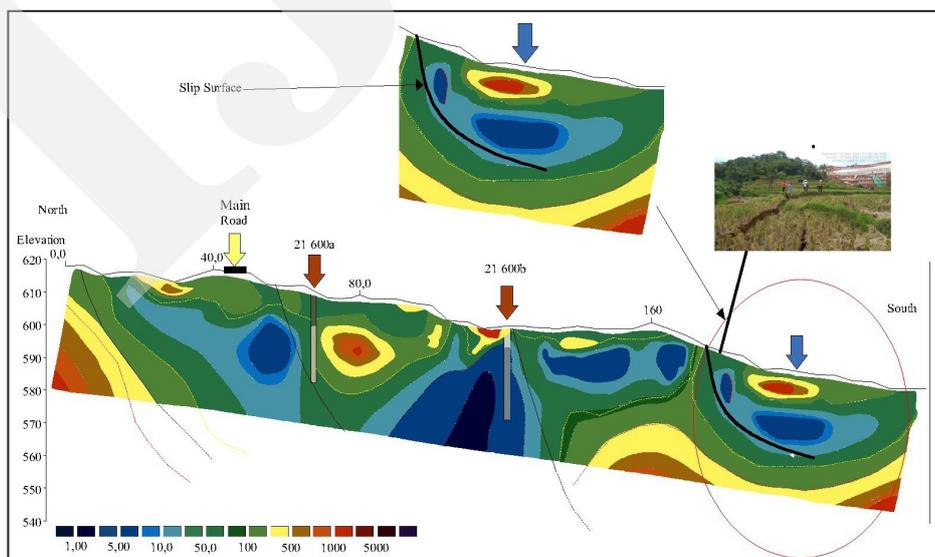
Figure 7. Section of 2D resistivity for Line 4A.

However, the majority of Line 4A (Figure 7) was in the centre, on the right with a shallower depth, and on the left with some deeper depths inside the resistivity images. The bore core data of Station 21+600 and Station 21+550A were used to interpret the subsurface layer. Based on Station 21+600, the subsurface profile material began as a medium stiff layer of clay to sandy clay at a depth of 9 m, which gradually changed to a harder layer at a deeper level.

Based on both resistivity images produced in Figure 7, the hard zone was randomly distributed. The resistivity images in Figures 5, 6, and 7 also demonstrated that the thickness of the existing hard materials varied approximately from 10 m to 30 m.

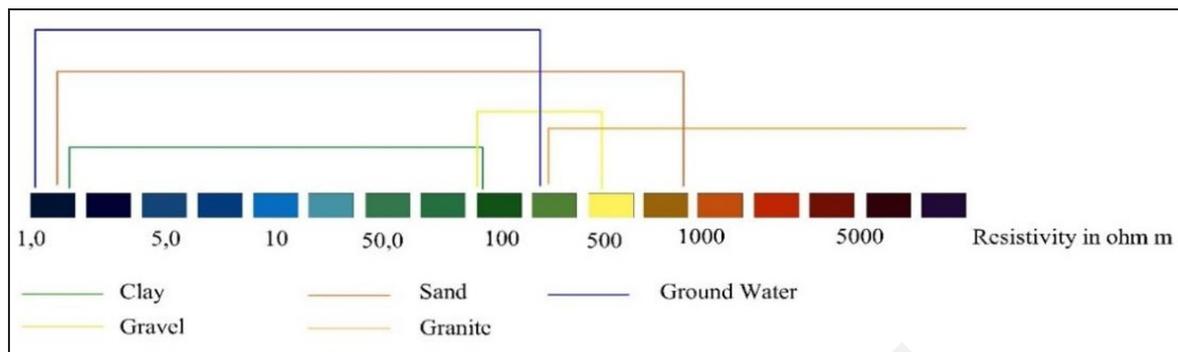
Figure 8. Summary of resistivity interpretation on Cisumdawu Highway.

The layer with a low resistivity value is water-saturated and silt or clay at 1–100 Ω m. A fairly higher resistivity value was discovered below the water-saturated layer and a harder rock in some places, with a resistivity of 50–200 Ω m, which is assumed to be clay. The boundary between the two layers or fields with different resistivity values was considered a slip surface.

21+600 and Station 21+550A of Cisumdawu Highway reveals that the percolating water zone in the permeable loose soil is located above the clay that is impermeable zone having N-SPT values between 40–60 at a depth of 24–26m, and is a landslide sliding surface (Figure 8). Therefore, this region needs to be strengthened or protected in the future using proper geotechnical ground stabilization procedures.

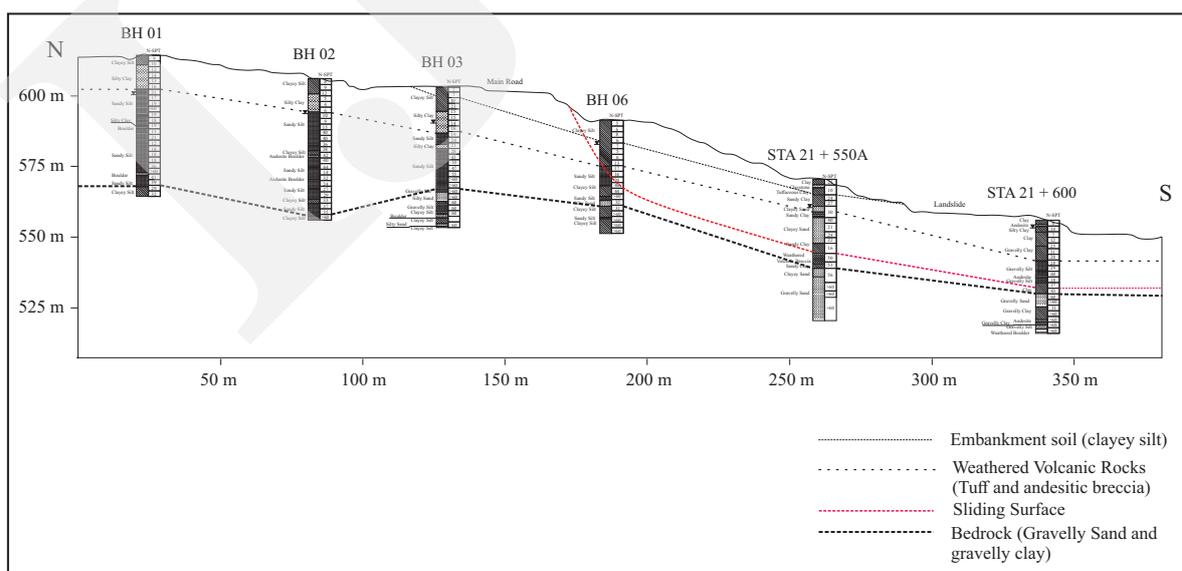
Based on the geotechnical cross-section through boreholes BH1, BH2, BH3, BH6, Sta 21+550A, and Sta 21+600 along Line 3A (Figure 9), the lithology of the researched area can be divided into four sections. They are the embankment soil (clayey soil) at a depth of 0-10 m with an N-SPT value of 5-10. The weathered volcanic rocks (tuff and andesitic breccia) at a depth of 10-15 m have an N-SPT value of 6-27. The weathered volcanic rocks (tuff and andesitic breccia) at a depth of 15-37 m have an N-SPT value of 10-32. The bedrock (gravelly sand and gravelly clay) at a depth of >37m has an N_SPT 32-60. Lithology of the sliding surface (red dashed line) is sandy silt, sandy clay, and clay with an N-SPT of more than 40.

Lithology of the sliding surface is sandy silt, sandy clay, and clay at a depth of 24 –26 m. The slope of the sliding surface is 20° with an N-SPT of more than 27. The results of this study can be used practically for determining a slip surface at the site .

Figure 9. Geotechnical cross-section for some boreholes at Cisumdawu Highway Station 21. The cross-section shows the lithology correlation between each borehole. The dashed red line shows the estimated sliding surface of each borehole.

Based on the data presented, the installation of bore piles and groundwater level monitoring need to be done as mitigation efforts. The framework implemented in this study is beneficial, and other landslide investigations can benefit from the combination of similar methods. For further research, the determination of rocks or soil weathering is recommended. Planning landslide mitigation using the advice from previous studies is also beneficial.
