**INDONESIAN JOURNAL ON GEOSCIENCE** Geological Agency Ministry of Energy and Mineral Resources Journal homepage: http://ijog.geologi.esdm.go.id ISSN 2355-9314, e-ISSN 2355-9306

# The Sliding Surface Determination of A Deep-seated Landslide on Cisumdawu Highway, West Java, Based on The Electrical Resistivity Tomography

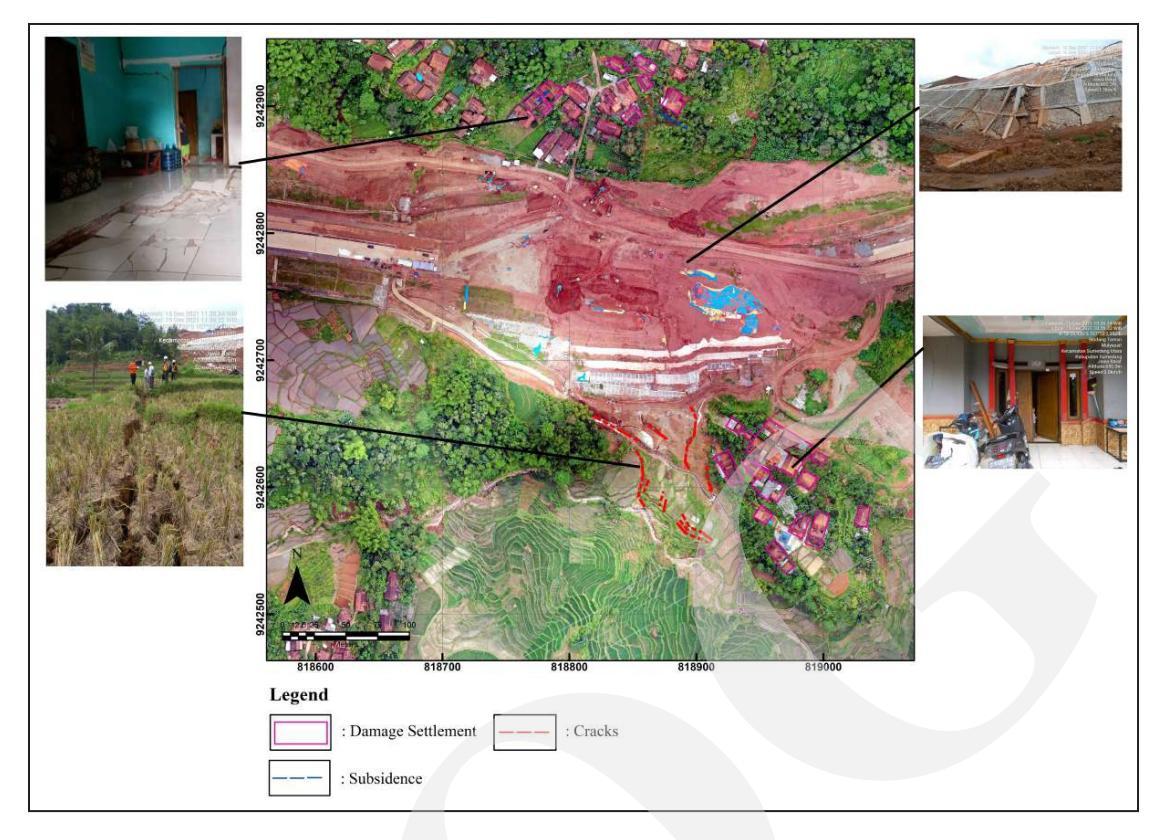
Figure 2. Landslide effects on infrastructure and buildings on Cisumdawu Highway Station 21.

The direction of the slow-moving landslide is N 170-180° E, and is characterized by cracks and land subsidence in residential areas, plantation lands, rice fields, and highways. The slow-moving landslide and land subsidence occurred on an under-construction highway, settlements, and paddy fields. These caused eighteen residents' houses, including the foundation and floor, be moderately damaged. Generally, the land in this area is used as settlement and rice field. (Figure 2).

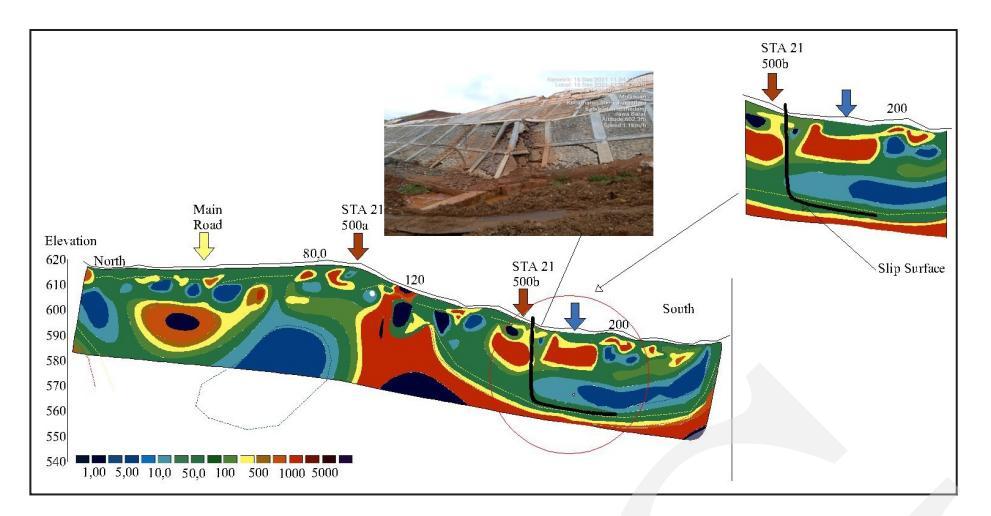
Figure 5. Section of 2D resistivity for Line 2A.

For Line 2A (Figure 5), several soil gradations were detected in a scattered distribution. In Line 3A (Figure 6), the result showed that several watersaturated zones were detected from the north to the south. The boundary between the zone with a low resistivity value and a harder rock in the south part is interpreted as a slip surface. The localized weak zone extending from the left to the right side was 24–26m deep from the north to the south.

In line 4A (Figure 7), the result showed that the resistivity tomography for permeable soil percolated with water was mainly located at the left-hand side with a shallow depth, the right-hand side, and within the resistivity image produced. For Line 2A (Figure 5), it was discovered that the resistivity tomography of permeable soil percolated with water accumulation was mainly located at the centre and slightly downslope to the southern area. Due to the presence of a percolated water zone, the zone of low resistivity value was produced. This zone might have developed due to water seepage from surface runoff, direct precipitation through porous subsurface materials, and the pre-existing groundwater zone in the area.

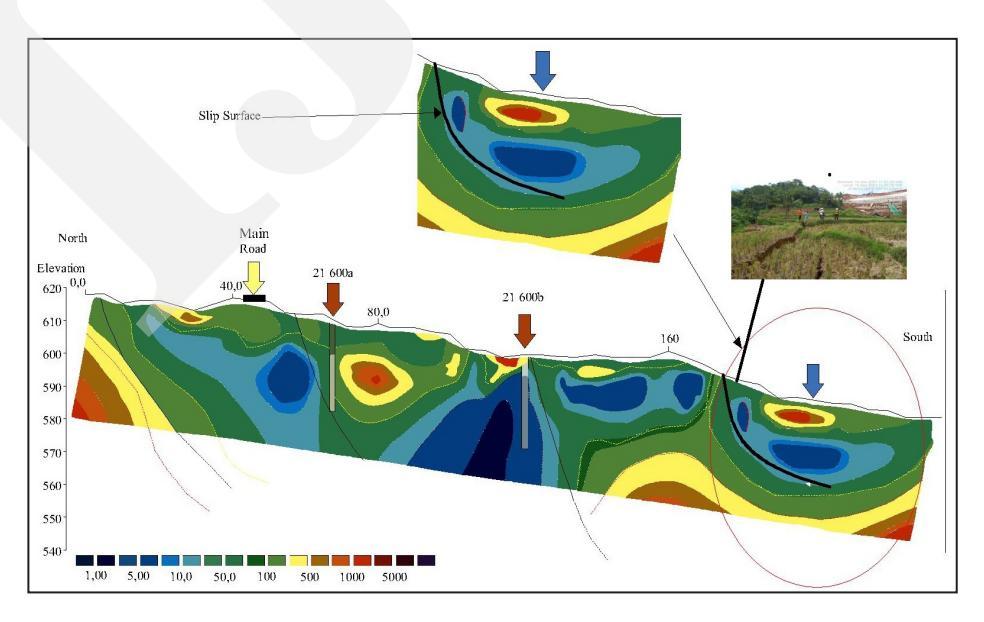
Figure 7. Section of 2D resistivity for Line 4A.

However, the majority of Line 4A (Figure 7) was in the centre, on the right with a shallower depth, and on the left with some deeper depths inside the resistivity images. The bore core data of Station 21+600 and Station 21+550A were used to interpret the subsurface layer. Based on Station 21+600, the subsurface profile material began as a medium stiff layer of clay to sandy clay at a depth of 9 m, which gradually changed to a harder layer at a deeper level.

Based on both resistivity images produced in Figure 7, the hard zone was randomly distributed. The resistivity images in Figures 5, 6, and 7 also demonstrated that the thickness of the existing hard materials varied approximately from 10 m to 30 m.

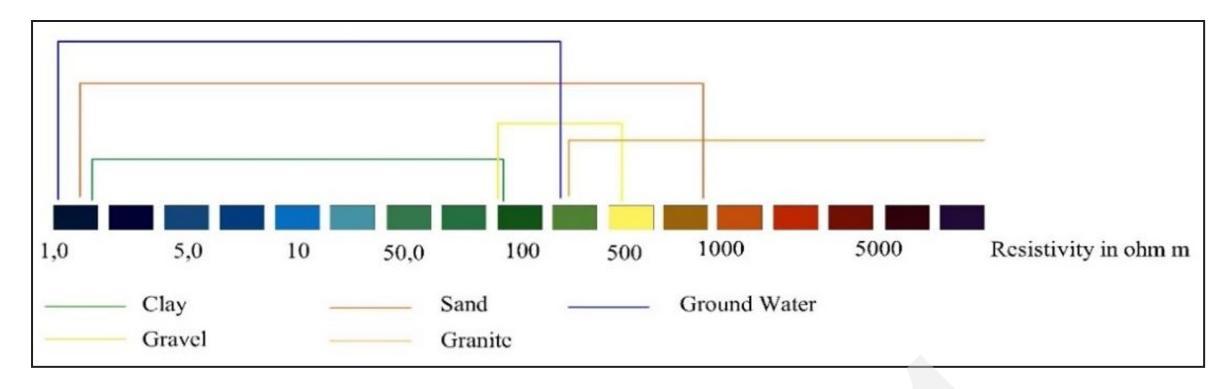
Figure 8. Summary of resistivity interpretation on Cisumdawu Highway.

The layer with a low resistivity value is watersaturated and silt or clay at 1–100  $\Omega$ m. A fairly higher resistivity value was discovered below the water-saturated layer and a harder rock in some places, with a resistivity of 50–200  $\Omega$ m, which is assumed to be clay. The boundary between the two layers or fields with different resistivity values was considered a slip surface.

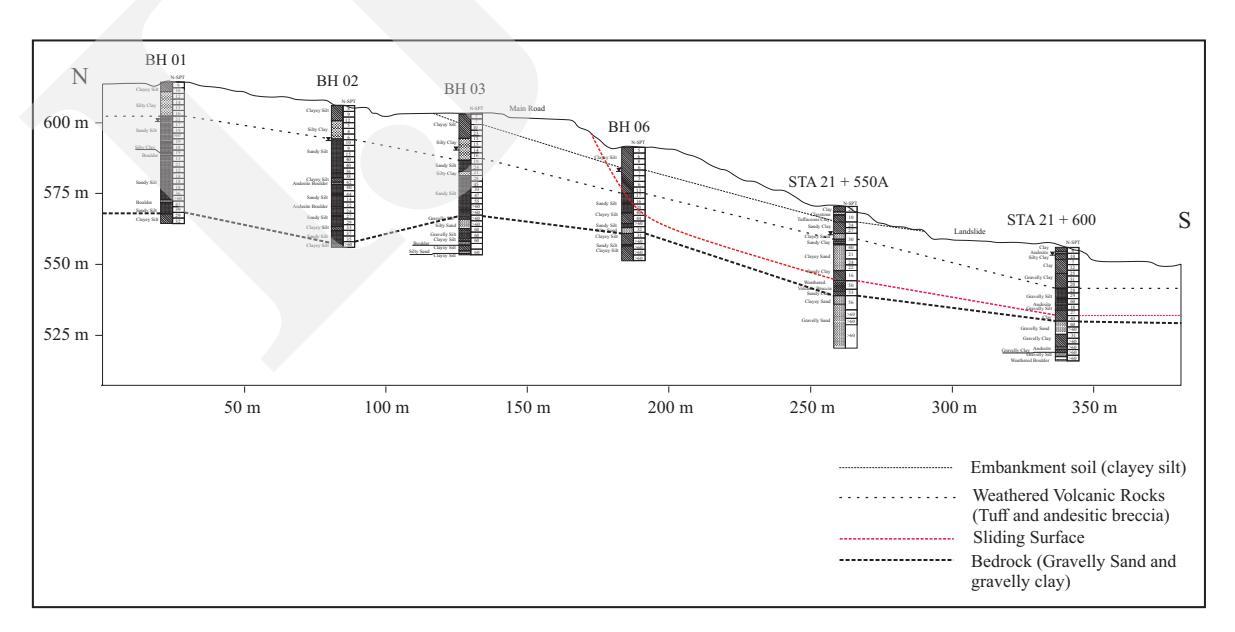
Based on the geotechnical cross-section through boreholes BH1, BH2, BH3, BH6, Sta 21+550A, and Sta 21+600 along Line 3A (Figure 9), the lithology of the researched area can be divided into four sections. They are the embankment soil (clayey soil) at a depth of 0-10 m with an N-SPT value of 5-10. The weathered volcanic rocks (tuff and andesitic breccia) at a depth of 10-15 m have an N-SPT value of 6-27. The weathered volcanic rocks (tuff and andesitic breccia) at a depth of 15-37 m have an N-SPT value of 10-32. The bedrock (gravelly sand and gravelly clay) at a depth of >37m has an N SPT 32-60. Lithology of the sliding surface (red dashed line) is sandy silt, sandy clay, and clay with an N-SPT of more than 40.

Lithology of the sliding surface is sandy silt, sandy clay, and clay at a depth of 24 –26 m. The slope of the sliding surface is 20° with an N-SPT of more than 27. The results of this study can be used practically for determining a slip surface at the site .

Figure 9. Geotechnical cross-section for some boreholes at Cisumdawu Highway Station 21. The cross-section shows the lithologic correlation between each borehole. The dashed red line shows the estimated sliding surface of each borehole.

Based on the data presented, the installation of bore piles and groundwater level monitoring need to be done as mitigation efforts. The framework implemented in this study is beneficial, and other landslide investigations can benefit from the combination of similar methods. For further research, the determination of rocks or soil weathering is recommended. Planning landslide mitigation using the advice from previous studies is also beneficial.
