Land Management for Reducing Bank Erosion: Using AHP Method and GIS Technique: A Case Study in Dibru River Basin, Assam India

GULAP SONOWAL¹ and GITIKA THAKURIAH²

Sonowal, G. and Thakuria, G., 2025. Land Management for Reducing Bank Erosion: Using AHP Method and GIS Technique: A Case Study in Dibru River Basin, Assam India. *Indonesian Journal on Geoscience*, 12 (1), p.25-41. DOI: [10.17014/ijog.12.1.25-41](https://doi.org/10.17014/ijog.12.1.25-41)

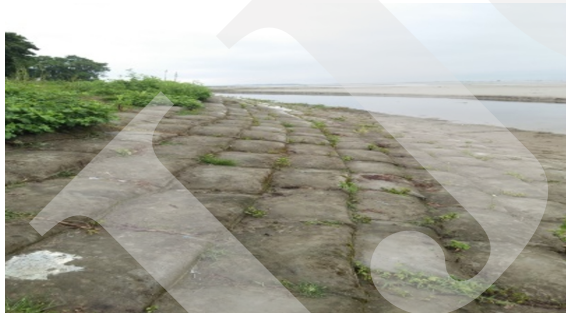
Figure 9. Photograph of Minalpur Village using geotextiles technique. Anti-erosion works along with the left bank of Jia-Bharali River, Assam Manish Gupta, Suresh Maurya, and Chitra River, Central Soil and Materials Research Station (CSMRS), New Delhi- 110016.

This technique is observed all over Assam to minimize bank erosion took place 1977-2020 in Dibru Basin (Figures 9 and 10). Geotextile embankment is observed in Matmora in Dhakukhana Subdivision of Lakhimpur District, left bank of Jia-Bharali River (Figure 9).

Construction of embankment by using geotextile technique also called geotube or geobag embankment (Figure 9), is a cost-effective and ecologically-friendly process to mitigate erosion on the riverbank (Mondal *et al.*, 2012). The geotube embankment to a success story of preventing flood and bank erosion was due to proper maintenance and frequent monitoring system. Remarkably, the problem of bank erosion nearby a village can be minimized by building a geotube embankment.

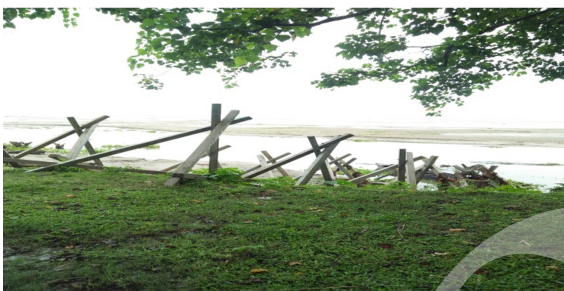
Figure 13. Photograph of installation of porcupine method in Minalpur Village.

Very recently, the method of porcupine (Figure 13) has been adopted by the government. However, the villagers are not satisfied with applying this method during the monsoon period instead of non-monsoon.
