## Land Management for Reducing Bank Erosion: Using AHP Method and GIS Technique: A Case Study in Dibru River Basin, Assam India

GULAP SONOWAL<sup>1</sup> and GITIKA THAKURIAH<sup>2</sup>

Sonowal, G. and Thakuriah, G., 2025. Land Management for Reducing Bank Erosion: Using AHP Method and GIS Technique: A Case Study in Dibru River Basin, Assam India. *Indonesian Journal on Geoscience*, 12 (1), p.25-41. DOI: [10.17014/ijog.12.1.25-41](https://doi.org/10.17014/ijog.12.1.25-41)

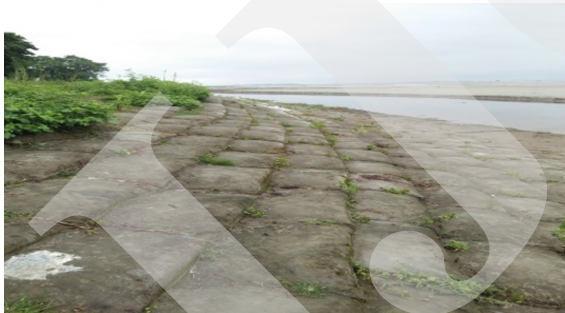
Figure 9. Photograph of Minalpur Village using geotextiles technique. Anti-erosion works along with the left bank of Jiabharali River, Assam Manish Gupta, Suresh Maurya, and Chitra River, Central Soil and Materials Research Station (CSMRS), New Delhi- 110016.

This technique is observed all over Assam to minimize bank erosion took place 1977-2020 in Dibru Basin (Figures 9 and 10). Geotextile embankment is observed in Matmora in Dhakukhana Subdivision of Lakhimpur District, left bank of Jia-Bharali River (Figure 9).

Construction of embankment by using geotextile technique also called geotube or geobag embankment (Figure 9), is a cost-effective and ecologically-friendly process to mitigate erosion on the riverbank (Mondal *et al.*, 2012). The geotube embankment to a success story of preventing flood and bank erosion was due to proper maintenance and frequent monitoring system. Remarkably, the problem of bank erosion nearby a village can be minimized by building a geotube embankment.

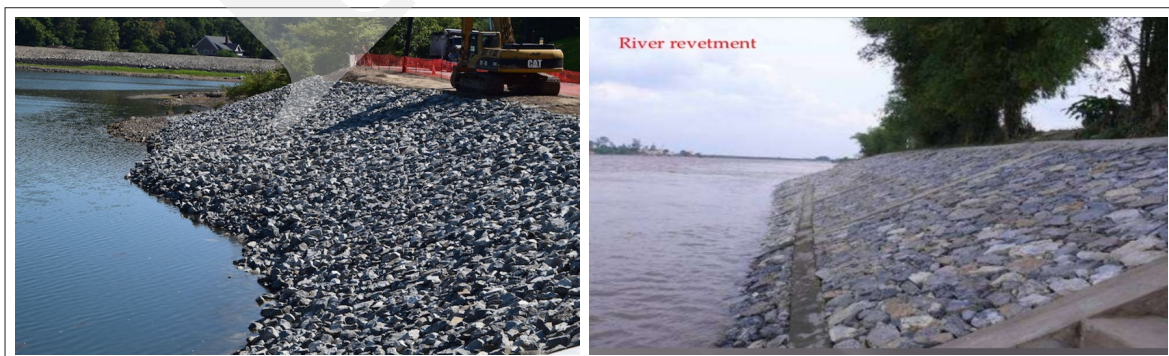
Figure 11. Photographs of riprap or rock fills/river revetment (Poa St. James. Erosion Control and Pond Bank Stabilization Methods).

Construction of protective wall-like structures, including revetment wall, groyne, and porcupine minimizes the effects of erosion. River revetments are sloping structures placed on banks to protect them against erosion. Similarly, groynes (Figure 12) are structures constructed perpen-
