## Geothermal System as the Cause of the 1979 Landslide Tsunami in Lembata Island, Indonesia

**Abstract** - A tsunami landslide which caused hundreds casualties and lots of damage took place on Lembata Island in 1979. In order to understand the characteristics of the landslide mechanism, a field survey was conducted in 2013 which sampled both the origin soil and landslide material, and the water from hot spring around the landslide site. The physical properties of the soil obtained show that the original soil has dominantly coarser grain than the landslide material (80.5% coarser grain compared to 11.8% coarse grain respectively) which indicates that the soil has become finer and softer. Hot spring analysis indicated that the mineral content of the water was 99.48%  $\text{SO}_4$ . This shows that magmatism processes are involved which caused the soil to become acidic and may have fragilised the system. Results of X-ray Diffraction Mineralogy Analysis (XRD) show that the original soil is composed of minerals of cristobalite, quartz, and albite, while the landslide material consists of clay minerals such as quartz, saponite, chabazite, silicon oxide, and coesite which are typical m

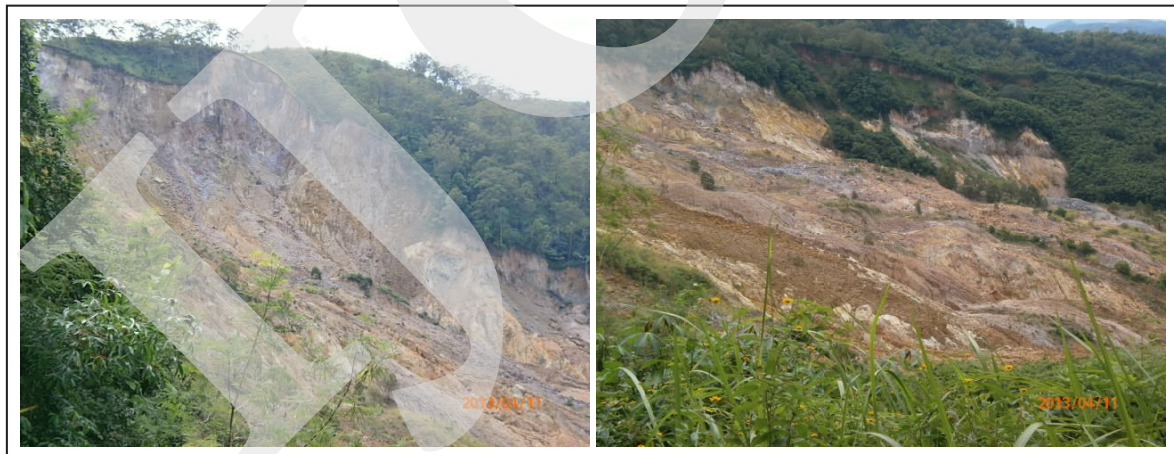
The landslide area is located at an old crater of Iliwerung complex. The crown of landslide is found at Atakore Village, named Bauraja Hill (Figure 5). The Bauraja Hill forms a cliff that is

Figure 5. Evidences of the 1979 landslide taken on April 2013, the crown (left) and the landslide body (right) (Yudhicara *et al.*, 2013).

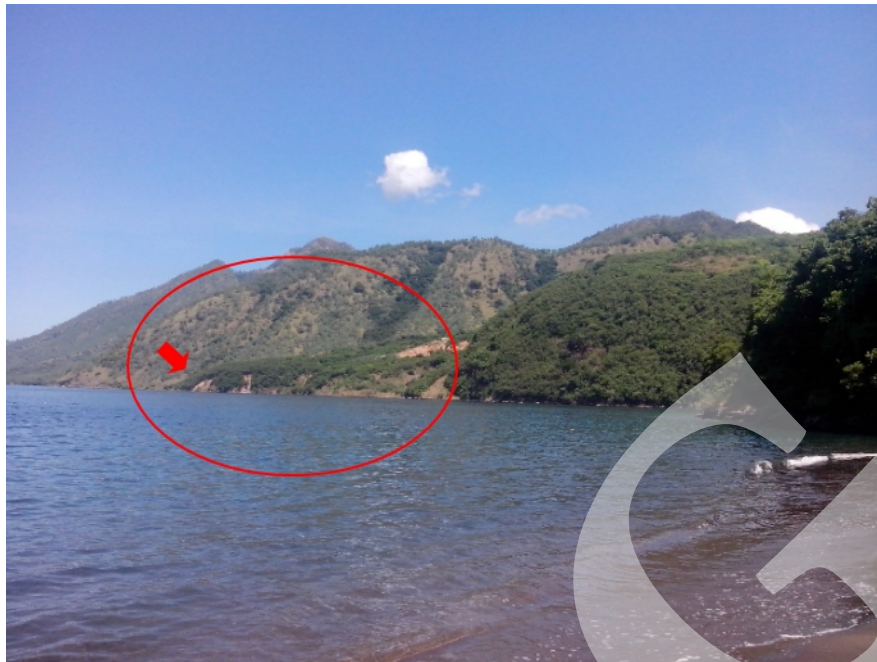
Figure 6. The landslide product protrudes into the sea (red circle); location of water sample is shown by red arrow (Yudhicara *et al.*, 2013).

material was taken nearby the sea (Figure 6), which has finer grain volcanic ashes, yellow to white colour, very soft, clayey, loose, slippery and easy to move.

Some hot springs were found around the landslide site indicating a fumarole system. A water sample was taken from a hot spring at the foot hill of the landslide material at position of 08°28'44"S - 123°33'34.3"E (Figure 6), which coincides with a fault line. The mixing of water
