The Stability of Metasedimentary Rock in Ranau, Sabah, Malaysia

ISMAIL ABD. RAHIM and BABA MUSTA

Abstract - The aim of this paper is to determine the stability of slopes and to propose preliminary rock cut slope protection and stabilization measures for Paleocene to Middle Eocene Trusmadi Formation along Marakau-Kigiok in Ranau, Sabah, Malaysia. The rock of Trusmadi Formation is slightly metamorphosed and dominated by interbeds of sandstone with quartz vein (metagreywacke), metamudstone, shale, slate, sheared sandstone, and mudstone. The rock unit can be divided into four geotechnical units namely arenaceous unit, argillaceous unit, interbedded unit, and sheared unit. Twelve slopes were selected for this study. Geological mapping, discontinuity survey, kinematic analysis, and prescriptive measure were used in this study. Results of this study conclude that the potential modes of failures are planar and wedge. Terrace, surface drainage, weep holes, horizontal drain, vegetation cover, wire mesh, slope reprofiling, and retaining structure were proposed protection and stabilization measures for the slopes in the studied area.

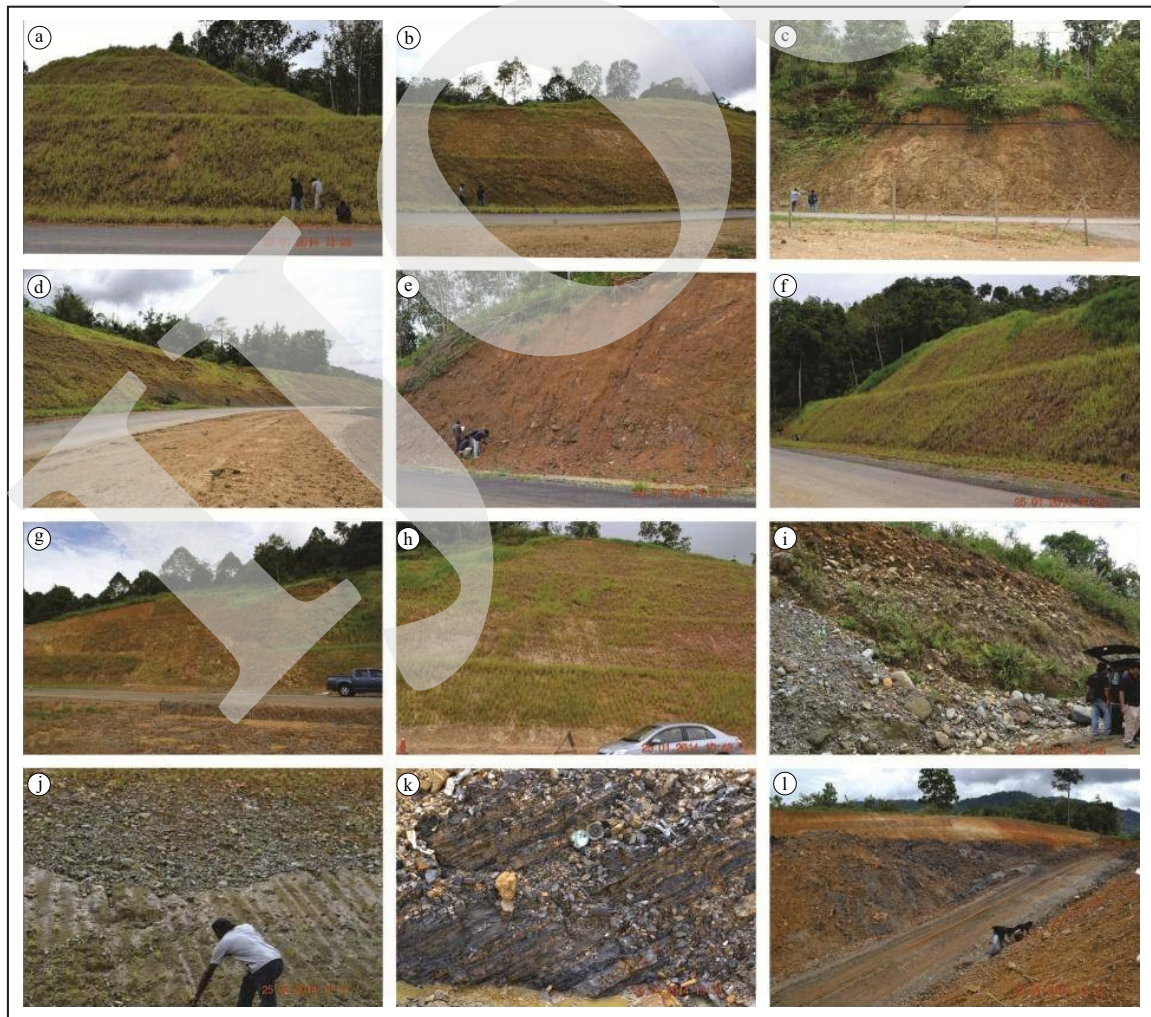
Figure 2. Slope sections. (a) slope 1; (b) slope 2; (c) slope 3; (d) slope 4; (e) slope 5; (f) slope 6; (g) slope 7; (h) slope 8; (i) slope 9; (j) slope 10; (k) slope 11 left; (l) slope 11 right.

The slope stability assessment was conducted on twelve slopes along the road (Figure 2). In this

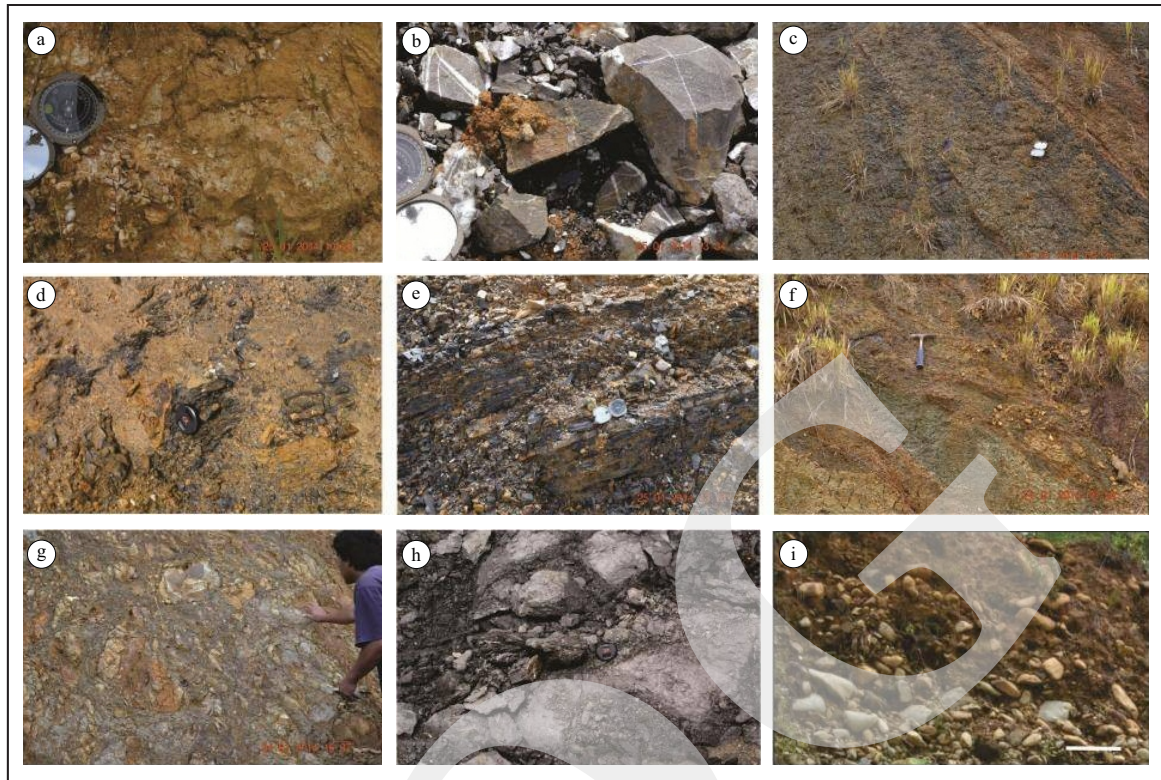
Figure 4. Geotechnical units. (a and b) arenaceous unit; (c and d) argillaceous unit; (e) interbedded unit; (f, g, and h) sheared unit; (i) alluvial unit.

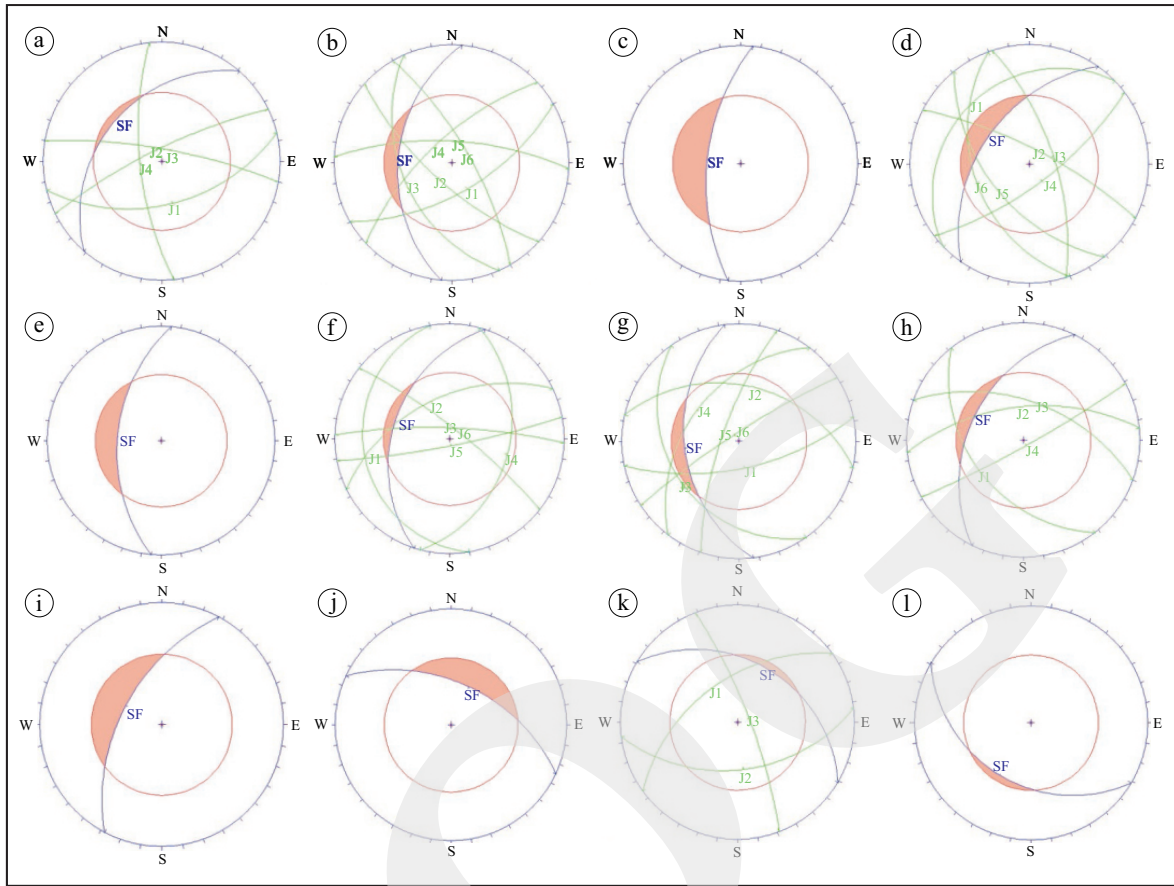
Figure 5. Result of the Markland test. Note: (a) slope S1; (b) slope S2; (c) slope S3; (d) slope S4; (e) slope S5; (f) slope S6; (g) slope S7; (h) slope S8; (i) slope S9; (j) slope S10; (k) slope S11L; (l) slope S11R; (J1) discontinuity 1; (J2) Discontinuity 2; (J3) discontinuity 3; (J4) discontinuity 4; (J5) discontinuity 5; (J6) discontinuity 6; (SF) slope face; mottled area- critical zone.

Discontinuities sets and mode of failures for the slopes are shown in Table 2 and Figure 5. The slopes consist of three to six sets of discontinuities, but undetermined for sheared unit (S3 and S5), argillaceous unit (S11 right), and alluvial unit (S9 and S10).

It is found that there are potential wedge failures in slope S2a, S4a, and S6a; but none for S1,

S7, S8, and S11 left. Circular failures were found to occur in slope S3, S5, S9, S10, and S11 right.
