## INDONESIAN JOURNAL ON GEOSCIENCE

### Analysis of Lithological Aspects and Their Influence on Slope Stability of the Failed Riverbank in Ajil, Hulu Terengganu, Malaysia

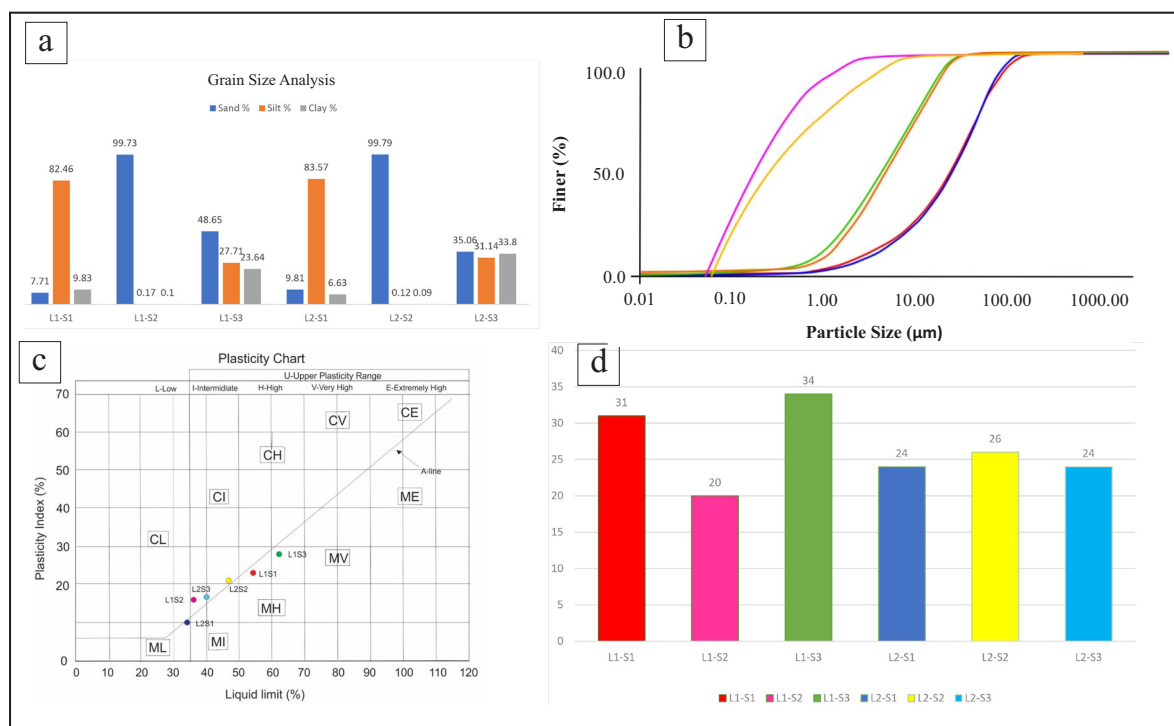
Soil samples L1S2 and L2S2 showed a high percentage of sand (>90 %), while the other samples had higher proportions of silt and clay (Figure 4a). The obtained grain size distribution data were presented in a graph, and the results classified each sample differently, although silt dominated the percentages (Figure 4b). Each sample was also analyzed to determine the uniformity coefficient (Cu) and the coefficient of curvature (Cc) to assess the grading quality of the particles. The calculations were based on cumulative distribution values at particle sizes D10, D30, and D60, as shown in the cumulative distribution graph (Table 1). From the calculations, the uniformity coefficient (Cu) ranged from 3.6 to 9.81. The coefficient of curvature (Cc) for samples L1S1, L1S2, and L2S1 ranged from 1.05 to 1.66, while samples L1S3 and L2S3 showed values of 0.63 and 0.71. Based on this information, samples in the L1S1, L1S2, L2S1, and L2S2 areas are categorized as well-graded, while samples in the L1S3

Figure 4. a) Grain size analysis chart of five samples. b) Particle size distribution graph showing positive-negative skewness comprising coarse-fine to silt-clay grains samples. c) Plasticity Chart plotted of each sample. d) Percentage of plasticity limits for each sample in the studied area.

Plastic limit tests indicated that sample L1S3 had the highest percentage at 34 %, followed by sample L1S1 at 31 %, sample L2S2 at 26 %, sample L2S3 at 25 %, and samples L1S2 and L2S1 at 24 % and 20 %, respectively (Figure 4d). Table 2 details the plasticity index values for each sample type. Calculations show plasticity indexes ranging from 10 % to 28 %, with notably high plasticity indexes in samples L1S1, L1S3, and L2S2. Soil classification was based on data plotted on the plasticity chart. According to the Unified Soil Classification System (USCS), analysis indicated that samples L1S2 and L2S2 fell above the A-line, and were classified as clay. Meanwhile, samples L1S1, L1S3, and L2S1, falling below the A-line, were classified as silt. Samples L1S2, L2S2, and L2S3 were categorized as CI, indicating clay with moderate plasticity.

Given their liquid limit below 50 % per ASTM D2487 classification, they are regarded as clayey silt. Samples L1S1 and L1S3 were classified as MH, referring to silt with high plasticity. Sample L2S1 was categorized as ML due to its liquid limit falling within the 34 % range, denoting a low plasticity index (Figure 4c). Soil failure occurs when it reaches its maximum stress level at a specific strain value. Plastic soil can endure an increase in strain within the soil. Soil failure due to peak stress may continue to bear stress, albeit with diminishing stress levels. According to Holtz and Kovacs (1981), soil that is semi-solid or brittle can withstand maximum applied stress, but will fail immediately afterward.
