### INDONESIAN JOURNAL ON GEOSCIENCE

# Analysis of Lithological Aspects and Their Influence on Slope Stability of the Failed Riverbank in Ajil, Hulu Terengganu, Malaysia

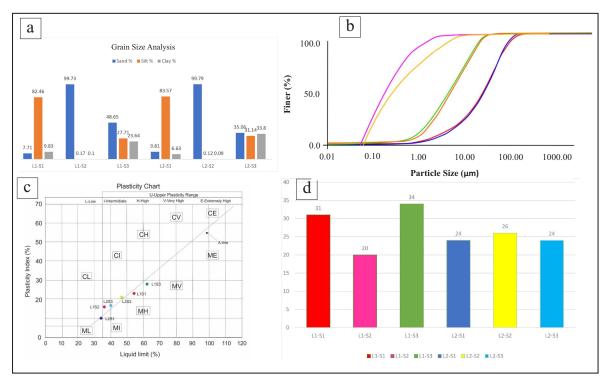
Soil samples L1S2 and L2S2 showed a high percentage of sand (>90 %), while the other samples had higher proportions of silt and clay (Figure 4a). The obtained grain size distribution data were presented in a graph, and the results classified each sample differently, although silt dominated the percentages (Figure 4b). Each sample was also analyzed to determine the uniformity coefficient (Cu) and the coefficient of curvature (Cc) to assess the grading quality of the particles. The calculations were based on cumulative distribution values at particle sizes D10, D30, and D60, as shown in the cumulative distribution graph (Table 1). From the calculations, the uniformity coefficient (Cu) ranged from 3.6 to 9.81. The coefficient of curvature (Cc) for samples L1S1, L1S2, and L2S1 ranged from 1.05 to 1.66, while samples L1S3 and L2S3 showed values of 0.63 and 0.71. Based on this information, samples in the L1S1, L1S2, L2S1, and L2S2 areas are categorized as well-graded, while samples in the L1S3

Figure 4. a) Grain size analysis chart of five samples. b) Particle size distribution graph showing positive-negative skewness comprising coarse-fine to silt-clay grains samples. c) Plasticity Chart plotted of each sample. d) Percentage of plasticity limits for each sample in the studied area.

Plastic limit tests indicated that sample L1S3 had the highest percentage at 34 %, followed by sample L1S1 at 31 %, sample L2S2 at 26 %, sample L2S3 at 25 %, and samples L1S2 and L2S1 at 24 % and 20 %, respectively (Figure 4d). Table 2 details the plasticity index values for each sample type. Calculations show plasticity indexes ranging from 10 % to 28 %, with notably high plasticity indexes in samples L1S1, L1S3, and L2S2. Soil classification was based on data plotted on the plasticity chart. According to the Unified Soil Classification System (USCS), analysis indicated that samples L1S2 and L2S2 fell above the A-line, and were classified as clay. Meanwhile, samples L1S1, L1S3, and L2S1, falling below the A-line, were classified as silt. Samples L1S2, L2S2, and L2S3 were categorized as CI, indicating clay with moderate plasticity.

Given their liquid limit below 50 % per ASTM D2487 classification, they are regarded as clayey silt. Samples L1S1 and L1S3 were classified as MH, referring to silt with high plasticity. Sample L2S1 was categorized as ML due to its liquid limit falling within the 34 % range, denoting a low plasticity index (Figure 4c). Soil failure occurs when it reaches its maximum stress level at a specific strain value. Plastic soil can endure an increase in strain within the soil. Soil failure due to peak stress may continue to bear stress, albeit with diminishing stress levels. According to Holtz and Kovacs (1981), soil that is semi-solid or brittle can withstand maximum applied stress, but will fail immediately afterward.
