**INDONESIAN JOURNAL ON GEOSCIENCE** Geological Agency Ministry of Energy and Mineral Resources Journal homepage: http://ijog.geologi.esdm.go.id ISSN 2355-9314, e-ISSN 2355-9306

# The Sliding Surface Determination of A Deep-seated Landslide on Cisumdawu Highway, West Java, Based on The Electrical Resistivity Tomography

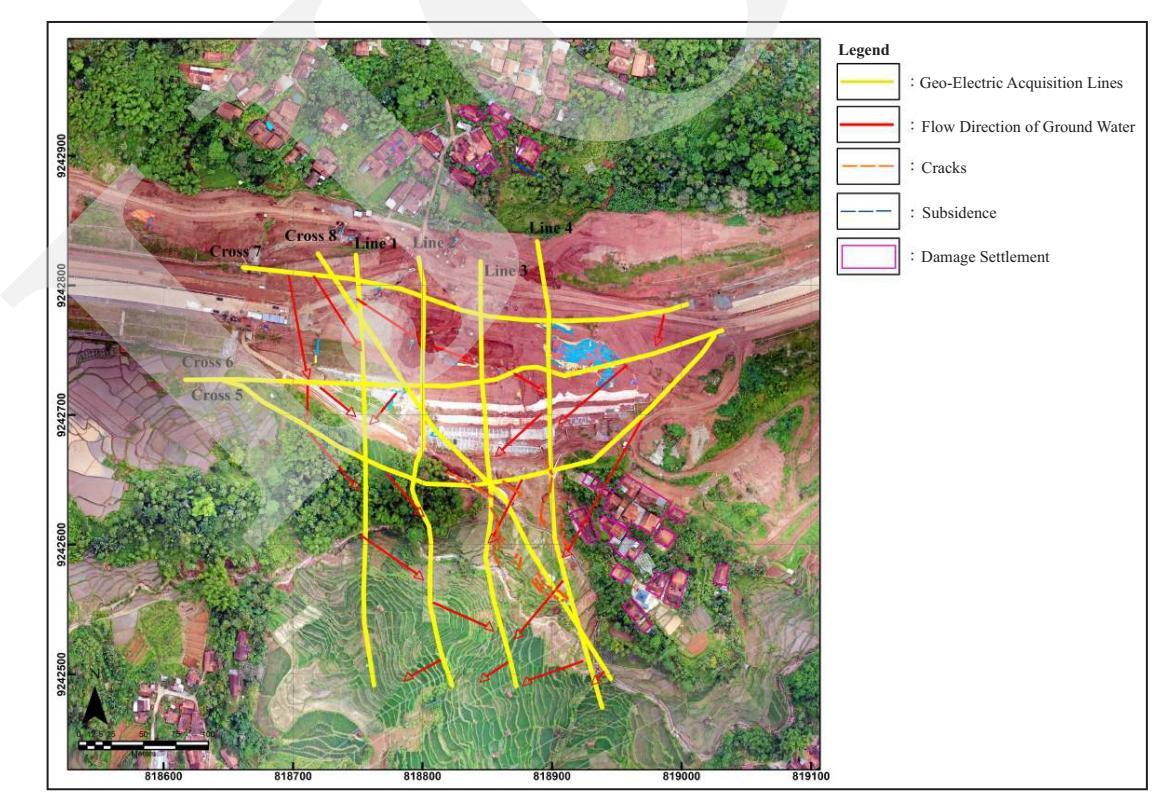
The resistivity method measurement was conducted by Kementerian PUPR in the researched area (Figure 4). The interpretation of resistivity measurement results was done by analyzing the resulting 2D cross-section. The resistivity value obtained was compared with the rock resistivity value from the reference (Telford, 1990), so that the subsurface structure of the studied area can be determined. In principle, the interpretation of this data processing was done to identify the presence of a slip surface as the first step in landslide mitigation.

Figure 4. A map of the resistivity measurement area (Kementerian PUPR, 2022). The yellow lines are geo-electric data acquisition lines. Red arrows show the general direction of groundwater.
