The Sliding Surface Determination of A Deep-seated Landslide on Cisumdawu Highway, West Java, Based on The Electrical Resistivity Tomography

IMAM SANTOSA^{1,2}, NANA SULAKSANA², EUIS TINTIN YUNINGSIH², and ZUFIALDI ZAKARIA²

²Faculty of Geological Engineering, University of Padjadjaran

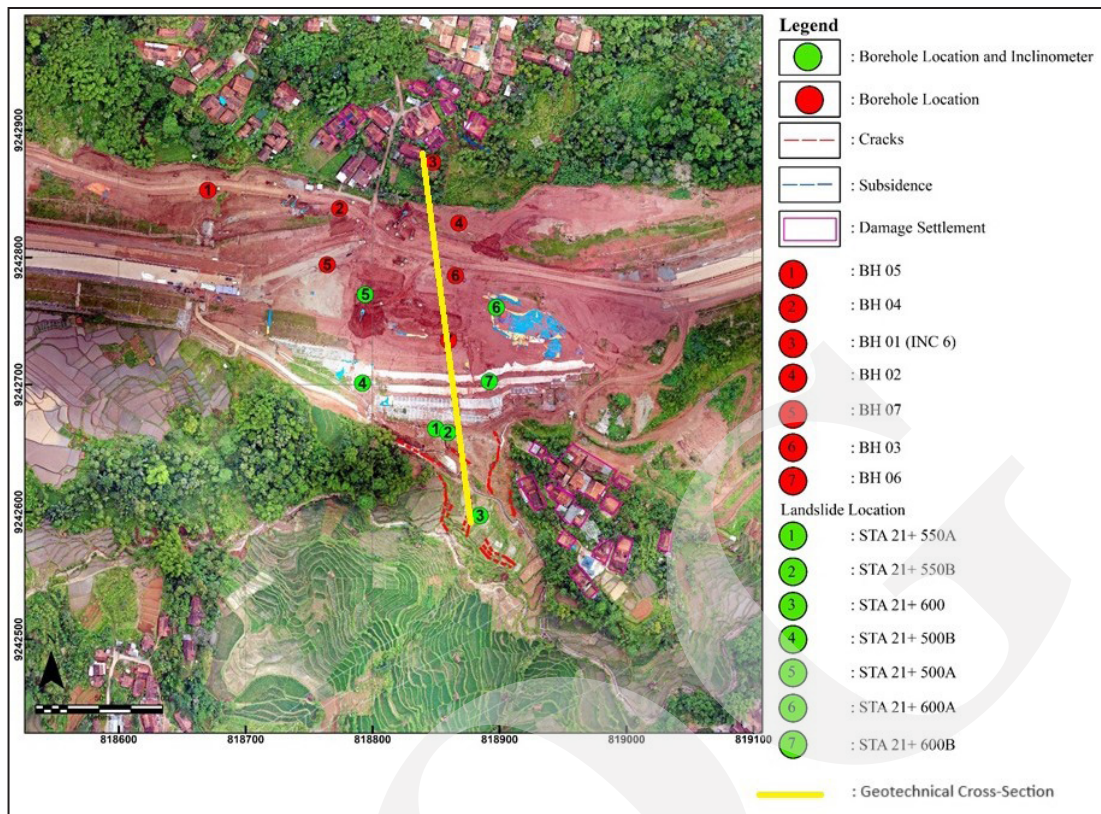
Borehole drilling has been carried out by the Ministry of Public Work and Housing to obtain undisturbed core samples, to conduct SPT (Standard Penetration Test), to observe and to determine the depth of the groundwater table. A total of fourteen boreholes are named BH1 (50 m), BH2 (50 m), BH3 (50 m), BH4 (40 m), BH5 (40 m), BH6 (40 m), BH7 (50 m), Station 21+500A (30 m), Station 21+550B (45 m), Station 550A (40 m), Station 550B (35 m), Station 600A (40 m), Station 600B (40 m), and Station 600 (40 m) (Figure 3). However, two boreholes, Station 600 and Station 550A, located near the landslide area as shown in Figure 3, were selected due to the significant data observed. In this research, an SPT was conducted to determine the soil consistency. The interval of SPT is 2 m.

Figure 3. Borehole locations along the Cisumdawu Highway of Station 21.

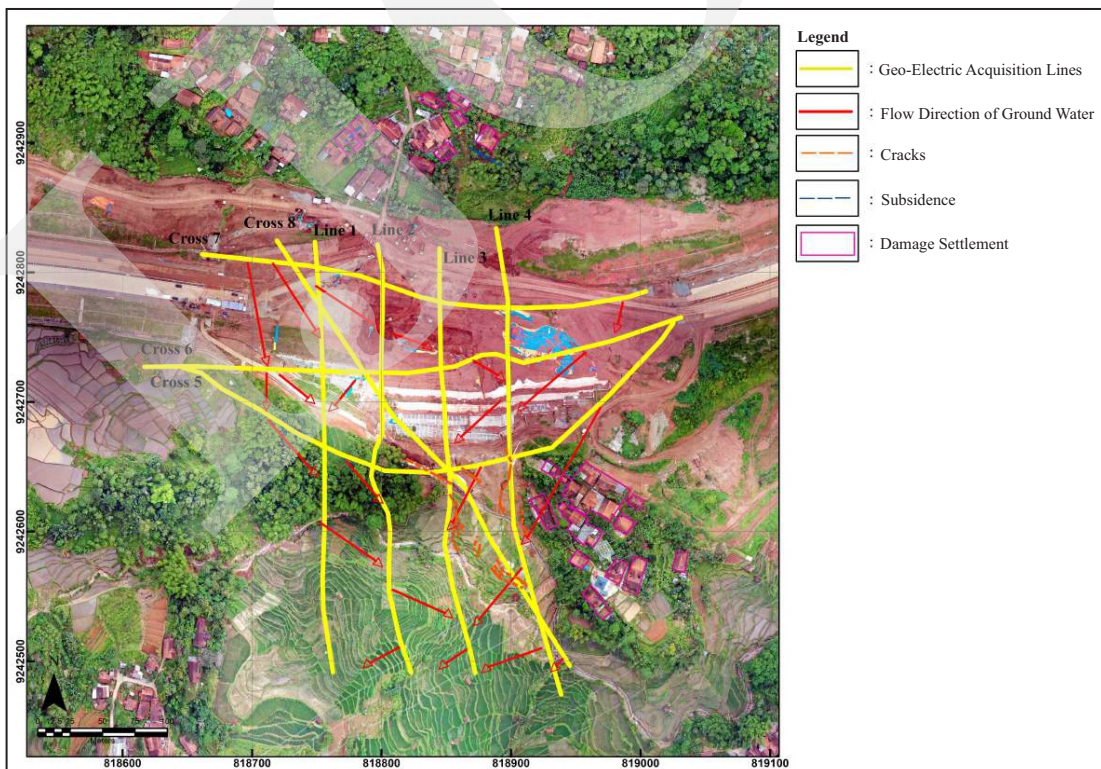
The resistivity method measurement was conducted by Kementerian PUPR in the researched area (Figure 4). The interpretation of resistivity measurement results was done by analyzing the resulting 2D cross-section. The resistivity value obtained was compared with the rock resistivity value from the reference (Telford, 1990), so that the subsurface structure of the studied area can be determined. In principle, the interpretation of this data processing was done to identify the presence of a slip surface as the first step in landslide mitigation.

Figure 4. A map of the resistivity measurement area (Kementerian PUPR, 2022). The yellow lines are geo-electric data acquisition lines. Red arrows show the general direction of groundwater.
