The Sliding Surface Determination of A Deep-seated Landslide on Cisumdawu Highway, West Java, Based on The Electrical Resistivity Tomography

IMAM SANTOSA^{1,2}, NANA SULAKSANA², EUIS TINTIN YUNINGSIH², and ZUFIALDI ZAKARIA²

Santosa, I., Sulaksana, N., Yuningsih, E.T., and Zakaria, Z., 2024. The Sliding Surface Determination of A Deep-seated Landslide on Cisumdawu Highway, West Java, Based on The Electrical Resistivity Tomography. *Indonesian Journal on Geoscience*, 11 (2), p.189-199. DOI: [10.17014/ijog.11.2.189-199](https://doi.org/10.17014/ijog.11.2.189-199)

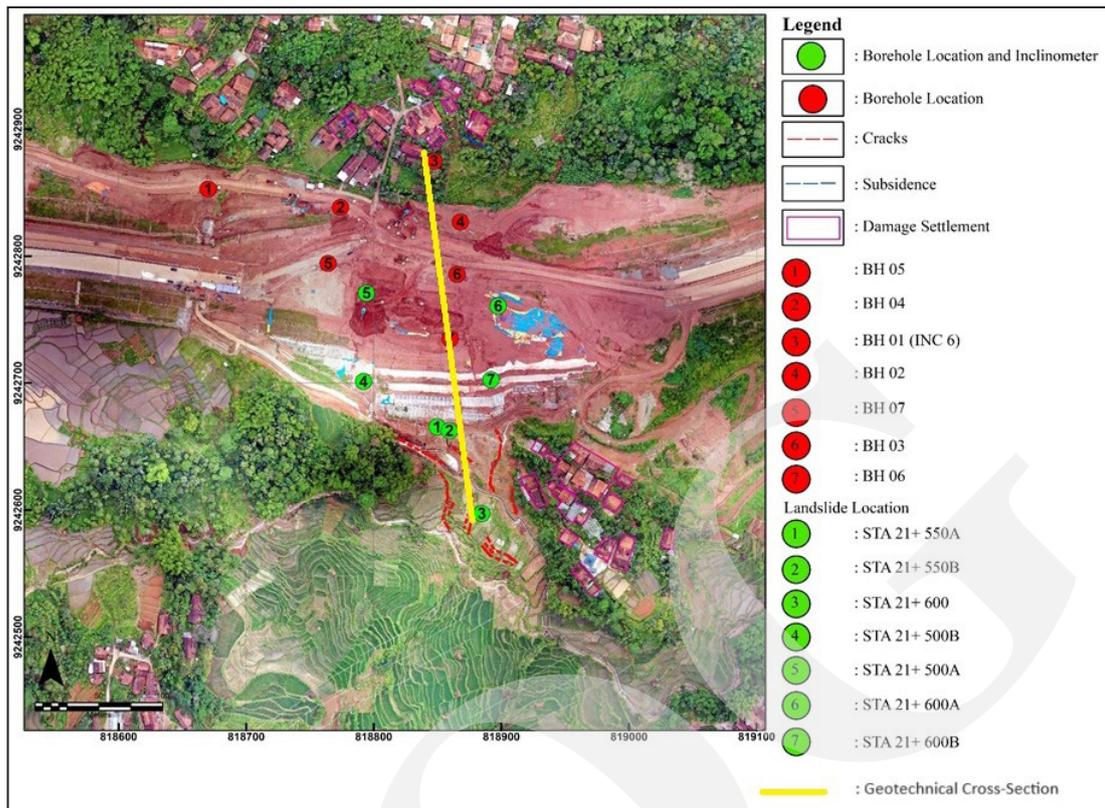
Borehole drilling has been carried out by the Ministry of Public Work and Housing to obtain undisturbed core samples, to conduct SPT (Standard Penetration Test), to observe and to determine the depth of the groundwater table. A total of fourteen boreholes are named BH1 (50 m), BH2 (50 m), BH3 (50 m), BH4 (40 m), BH5 (40 m), BH6 (40 m), BH7 (50 m), Station 21+500A (30 m), Station 21+550B (45 m), Station 550A (40 m), Station 550B (35 m), Station 600A (40 m), Station 600B (40 m), and Station 600 (40 m) (Figure 3). However, two boreholes, Station 600 and Station 550A, located near the landslide area as shown in Figure 3, were selected due to the significant data observed. In this research, an SPT was conducted to determine the soil consistency. The interval of SPT is 2 m.

Figure 3. Borehole locations along the Cisumdawu Highway of Station 21.

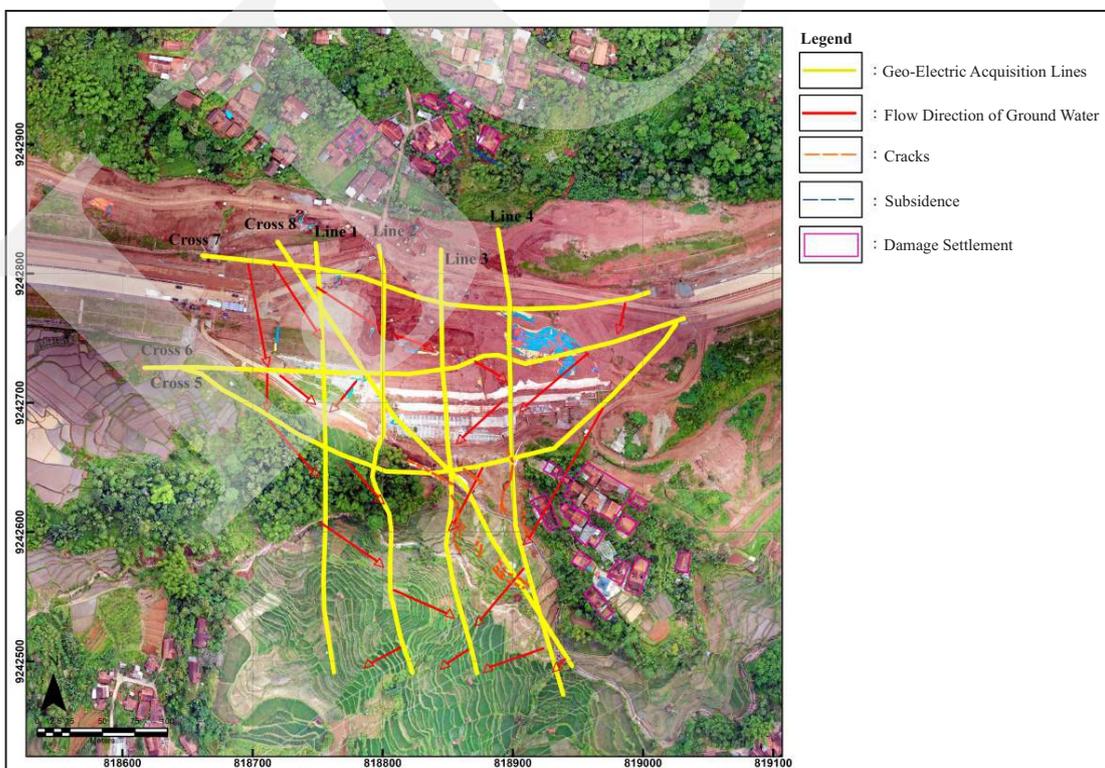
The resistivity method measurement was conducted by Kementerian PUPR in the researched area (Figure 4). The interpretation of resistivity measurement results was done by analyzing the resulting 2D cross-section. The resistivity value obtained was compared with the rock resistivity value from the reference (Telford, 1990), so that the subsurface structure of the studied area can be determined. In principle, the interpretation of this data processing was done to identify the presence of a slip surface as the first step in landslide mitigation.

Figure 4. A map of the resistivity measurement area (Kementerian PUPR, 2022). The yellow lines are geo-electric data acquisition lines. Red arrows show the general direction of groundwater.
